HISTORIC IRON COMPANY WORKERS COTTAGE
PRESERVATION PLAN

CITY OF LAKE OSWEGO

THE OFFICE OF ROBERT DORTIGNACQ ARCHITECT
MARCH 31, 2008

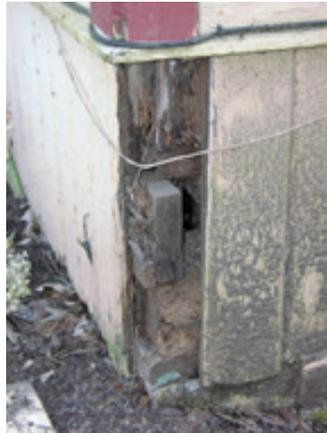
One of the most challenging repair aspects is addressing the deterioration on the lower portion of the sheathing support boards. It appears that these were the initial supporting members for the roof structure during construction. The interior board paneling and exterior channel siding were then applied to create a composite wall of three layers. While the exterior siding and the interior paneling are in good condition, the middle supporting layer is deteriorated where it secured to the floor structure. Correcting this defect is difficult, and complete repair may not be feasible since that would entail removing all of the exterior siding to replace a vertical member that is also attached to the interior wood boards. It may not even be desired from the preservation viewpoint since that type of repair may cause significant trauma.

Before discussing alternative repair options, it is necessary to review the overall building condition. This deterioration is not new, there have been prior attempts for repair, and the structure is relatively plumb, straight and intact. The cottage is a small, lightweight structure with a simple rectangular plan. Any repair option should also address the source of the deterioration - namely moisture at the lower wall. This entails creating a positive grade slope away from the structure and including provisions for reducing splash and carrying drainage away as discussed in the Site section below. Because the shape of the structure is not distressed and because of the difficulty in replacing damaged vertical sheathing boards, a limited rehabilitation strategy is recommended.

Complete removal of the exterior siding with subsequent attempt to replace sheathing boards could cause significant stress and potential collapse. Of course, this would be a very expensive option. Instead, a partial removal of only a few lower siding board courses is advised. This would allow access to the lower sheathing boards so that new material such as plywood or other suitable material could be installed and facilitate a connection between the remaining boards above and the perimeter beam below. The siding would then be reinstalled down to its original level. This work should be done incrementally and coordinated with adjacent substructure work so that only portions of the building are vulnerable at any given moment. It is expected that in some areas, particularly the corners, there will be more work involved. Only carpenters familiar with historic buildings should be pre-qualified and accepted for the work. The resulting repairs do not completely return the structure to an initial construction quality, but conserve the resource, and better its condition.

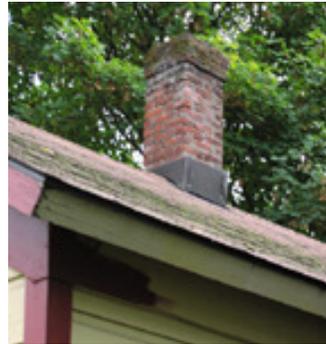
The existing attic ventilation at the main roof is sufficient, but should be incorporated into a slightly larger access door. Discreet ventilation needs to be provided for the shed roof portion. The brick chimney needs cleaning and has deteriorated joints that need repointing. New step flashing should be installed at the same time.

The roof could remain gutterless as it always has been. This would then remove the necessity for gutter maintenance, but improved drainage and splash control around the building should then be designed. Gutters should be provided for the rear shed roof with a simple painted metal half round gutter and round downspout that directs the runoff away from the building. This would be in consideration for entry and due to the lack of rear roof overhang, unless the roof is extended and a diverter utilized at the door. The front porch roof could also have a simple diverter over the entry path to deter drips.

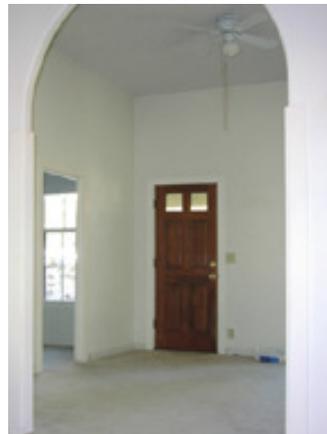
The historic interior wood finish on walls and floor, and wallpaper on the ceiling is mostly intact but has been covered by gypsum board and carpet. For continued residential use there is no need to remove these finishes. The removal would create additional rehabilitation work, and by leaving the material in place it preserves the wood surfaces from further damage, and provides slightly better thermal value. The floor, ceiling and wall surfaces in the kitchen are an exception. If this space is revised, the heavily textured surfaces should be removed. Some attic space access for the shed roof is advised. The floor is buckled and needs to be replaced. The kitchen layout could be improved by rearranging the sink, stove, washer and refrigerator. This work would be coordinated with exterior window alterations. Appliances can be replaced independently as wear dictates. The cupboards need new doors, and appropriate countertops and wall shelving/new cabinets.

The base cabinet should remain. The bathroom would have some alterations with a revised window. That work may allow installation of a mirror. The tub and sink need surface repair. Since there are no closets or storage areas, independent cabinets may be fabricated or purchased as a renter amenity and to minimize potential damage by alterations.

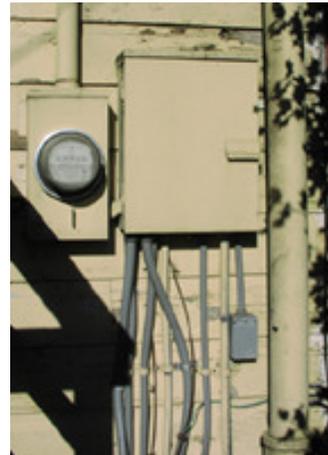
Both systems are operating satisfactorily and should serve residential use well. The furnace is an older model, but with its central location and the small spaces to heat, it has not had heavy use. Its replacement would be dictated by maintenance. If future cottage use changes, there may be a need for air conditioning if windows remain shut. For residential use, ceiling fans, operable windows and tall ceilings give adequate cooling. The electrical service, wiring and outlets have been replaced recently and fit residential needs. Those needs would change if the use changes. The exposed panel and conduit are an eyesore that could be improved by adding a suitable cover that would double as weather protection and security.

The cable wiring that circles the cottage should be rerouted to the crawl space with designated junction boxes installed at the interior, possibly in conjunction with telephone. The battery smoke detectors should be replaced with ones that are line voltage inerted types.

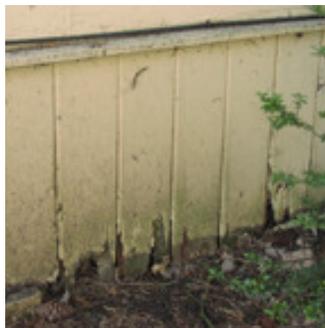
The channel siding and building trim is generally in good condition. There are areas needing attention, for example, near the revised window on the east wall where a former deck had been installed, there are holes through the wall exposing the backside of the interior gypsum board. There are other gaps and damage areas that need attention. The wall boards on the interior side are not able to be viewed, but are most likely in good condition. The primary vertical sheathing boards are the area of the most deterioration. It appears that many of their bottom sections have deteriorated, with some of that damage visible where the skirting is removed at the southwest and northwest corners. It appears that at one time these boards were cut off (note the random bottom edge remaining as seen in the photo opposite), filler material added, and a raised water table and taller skirting installed. It should be expected that the lower portion of these boards are damaged or have been cut off on the entire perimeter. The skirt boards are also deteriorated, but not as extensively as one would expect given their direct contact into the soil. This is probably due to their being a relatively new replacement.

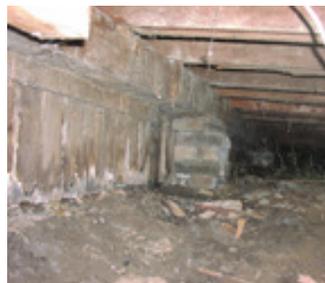
The floor structure displays some unevenness as noted on the interior that could be attributed to settling or member deterioration. There have been previous repairs of deteriorated members as well as alterations, especially in the area of the bathroom and kitchen and their plumbing. There, wafer board has replaced the wood flooring and new joists have been framed at the bathroom .

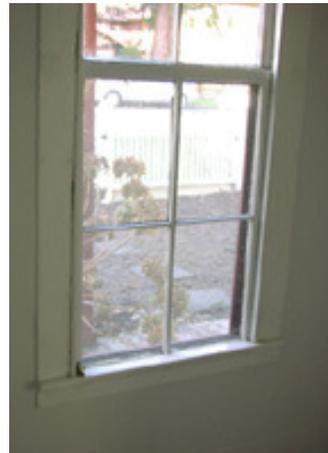
Most windows of the original wood double hung windows are intact. They measure 2'-3½" wide by 6'-5" high with a 22" high sill and 4/4 x 4½" flat casings. The sash is divided 4/4 and has thin muntins with the panes puttied in. There is no suspension system since the window relies on a frame trim piece for the solid wall termination and to hold the sash in place. The lower sashes are operable and held open by friction. The upper sashes are painted shut, but not have been operated. There is no hardware including; latches, lifts, suspension, or weatherstripping. Much of the glass appears to be historic. The southeast window has been changed to a white vinyl single hung that is wider. This opening had previously been enlarged to a terrace door that led to a deck on the east side yard. Some of the windows have wood frame screens, and the west ones have exterior metal storm windows.

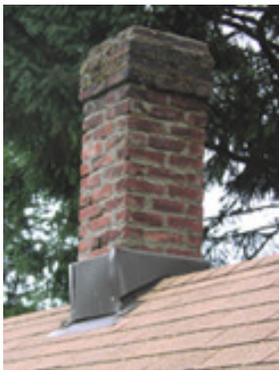
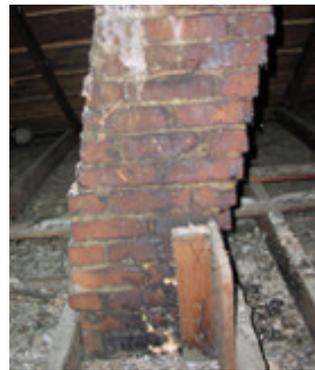
There is a single brick masonry chimney located on the ridge at the center of the house. It extends several feet and has a corbelled top. It has poorly fabricated, painted metal flashing to the roof. Within the attic the 16" square chimney is offset southward to clear existing ceiling joists at the mid cross wall. The masonry is terminated onto wood framing at the main level, at design that was often used for stove venting. The design thus indicates that this was always a heating stove vent and was never for a fireplace. The rear shed roof may have had a cookstove with a metal flue.

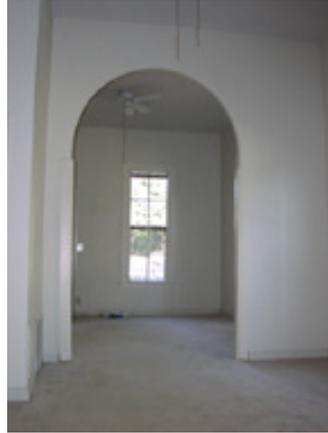
The interior cottage walls are solid wood similar to the exterior walls. They consist of two board layers, a vertical and a horizontal layer of tongue and groove boards. The kitchen wall is triple layered due to the sheathing boards supporting the roof gable above, and also has an additional finish layer on the kitchen side. The painted boards were the exposed finish for the cottage. Occasional vertical boards extend into the attic to secure the walls to ceiling joists (See attic chimney photo above). The ceiling was made by 1x4 boards applied to the bottom of the joists with a wall paper finish [remaining material is exposed in the furnace room]. The walls and the ceilings have been recently overlaid with painted 1/2" gypsum board that abuts the wall, door and window trim. There is minimal woodwork that consists of full sized 1x4 painted wood window and door casings and 1x6 baseboards; all of flat profile. The baseboards in the living room have been replaced with shorter, thinner material as are the new window casings. The cross wall in the living room has been modified with an arch top. An older interior photograph (2000) shows a rectangular opening. It has not been verified if this entire wall always existed. As verified in the attic, the portion by the chimney did exist for the chimney's support, and probably the remainder of the wall also since it provides added cross support. The five foot wide opening may have been narrower. These rooms have carpet installed over padding over the wood floor. In the kitchen and bath the flooring is sheet vinyl installed over thin plywood underlayment with rubber base. The finishes are generally in good condition except in the kitchen where the flooring is buckled and the ceiling is a heavily textured brocade - possibly to cover prior water damage.

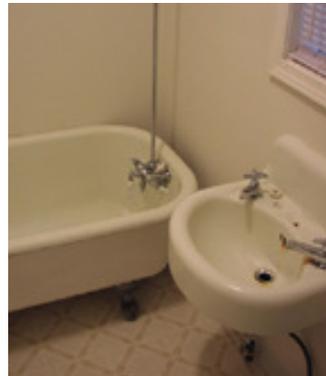
The kitchen has a newer stainless double bowl sink and faucet. The bathroom has a stained wall hung porcelain sink with separate hot and cold supply fittings, a small cast iron claw foot tub [its recoating is failing] with new replacement shower head riser and faucet, and a non historic water closet, all on the east wall. It appears that the sink and toilet may have previously been on the south wall. The water is heated by an electric heater exposed in the bathroom. The cast iron vent piping for the bath is exposed on the outside of the east exterior wall. Supply and drain piping is visible in the crawl space

and varies in materials used. Drain pipes are both cast iron and ABS. Much of the piping has been replaced. The condition and age of the main supply line is not known. Exposed lines in the crawl space are all insulated.
