August 6, 2013

Wizer Property
**Tree Inventory and
Preservation Plan**

Tree Health Assessment and Preservation Plan for Japanese Maple

Site:
Wizer shopping center
330 1st Street
Lake Oswego, Oregon 97034

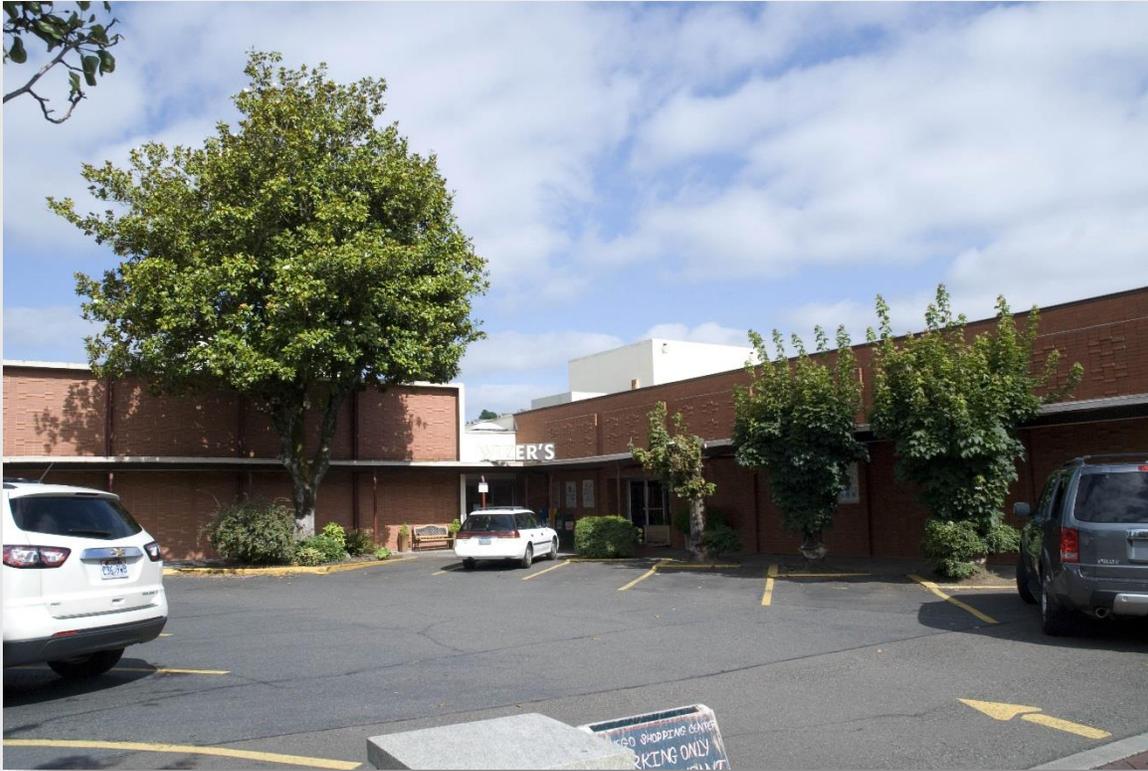
Photo 1 – taken July 8, 2013 looking northwest near the southeast corner. The magnolia and three Norway maples.

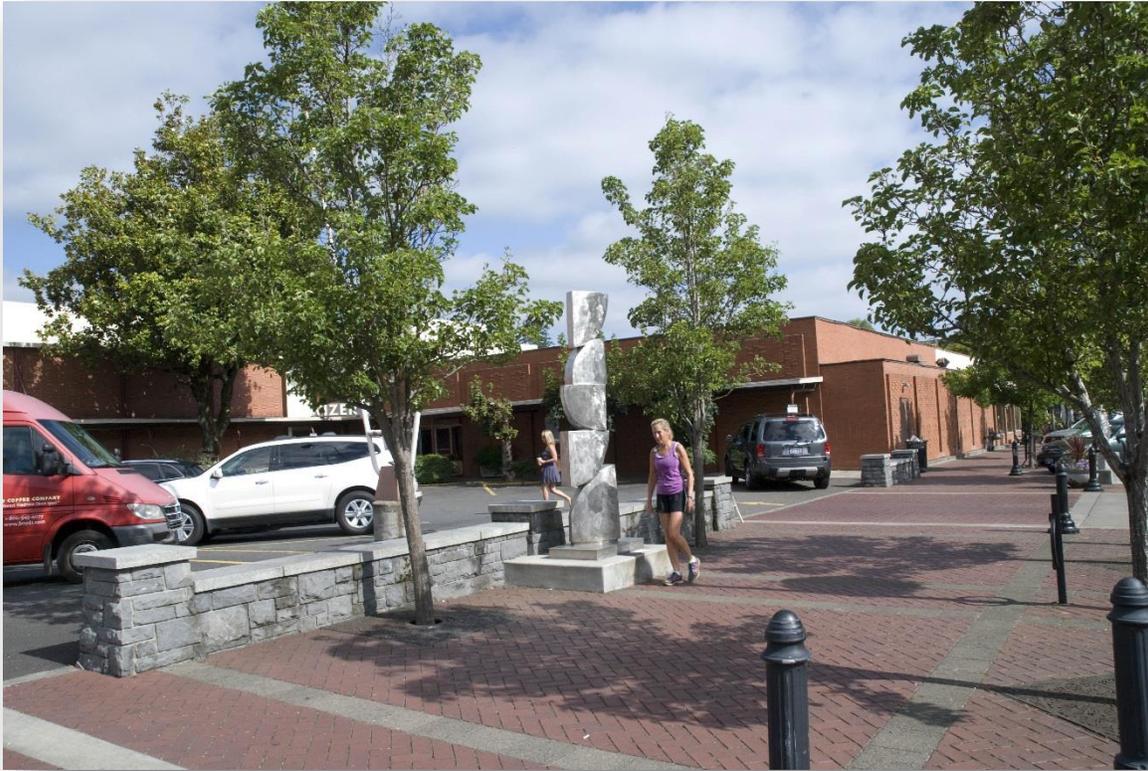
Photo 2

Photo 2: taken July 8, 2013 looking northwest near the southeast corner. Two of the four flowering pears near the proposed ramp to the below ground parking.

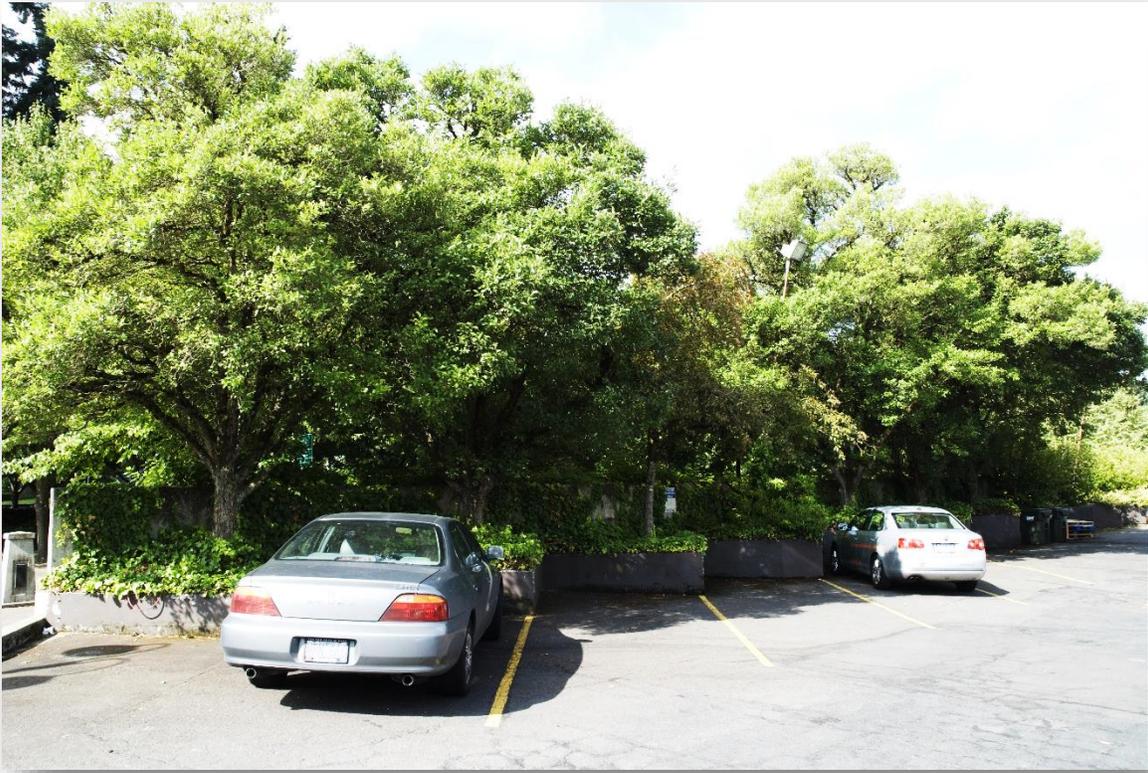
Photo 3

Photo 3: taken July 8, 2013 looking southwest from the southeast corner. The four Lavelle hawthorn in planters on the south end.

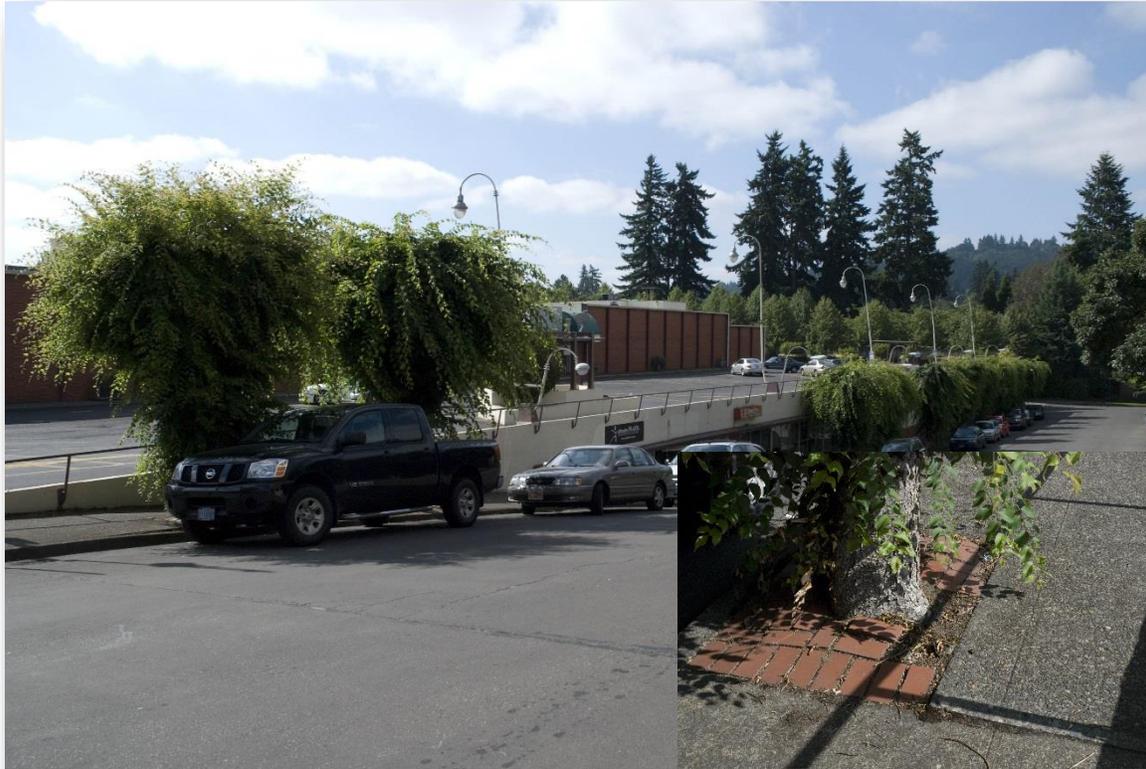
Photo 4 taken July 8, 2012 looking southwest at the northwest corner of the property with close up insert.
The row of zelkovas along First Street and insert of out grown planters.

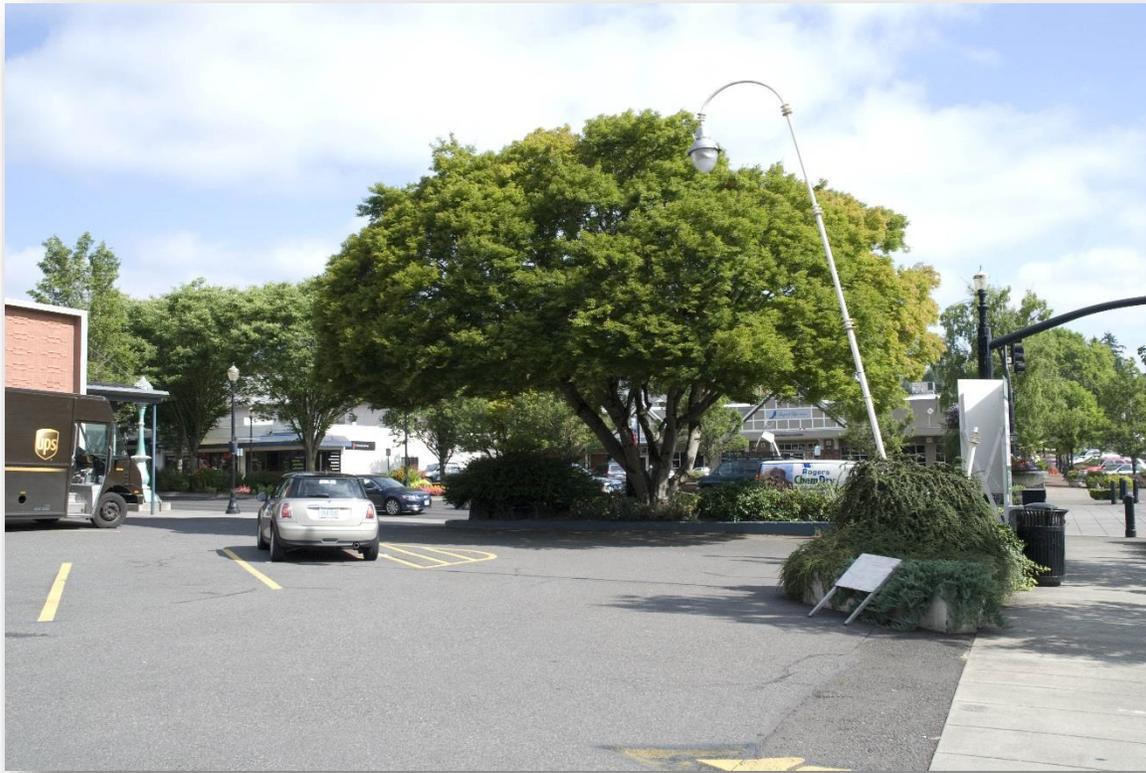
Photo 5 taken July 8, 2013 looking north along the near the north east side.
Specimen Japanese maple.

My recommendations for the preservation of the street trees along First Street, A Avenue and Evergreen Rd and the Japanese maple on the northeast corner are to follow the Tree Preservation s prescribed within the discussion. Install fencing around each tree at a minimum distance of five feet around the circumference of the trunk. Special attention and more detail will be needed once the final drawings are made around the Japanese maple. This tree may require special attention.

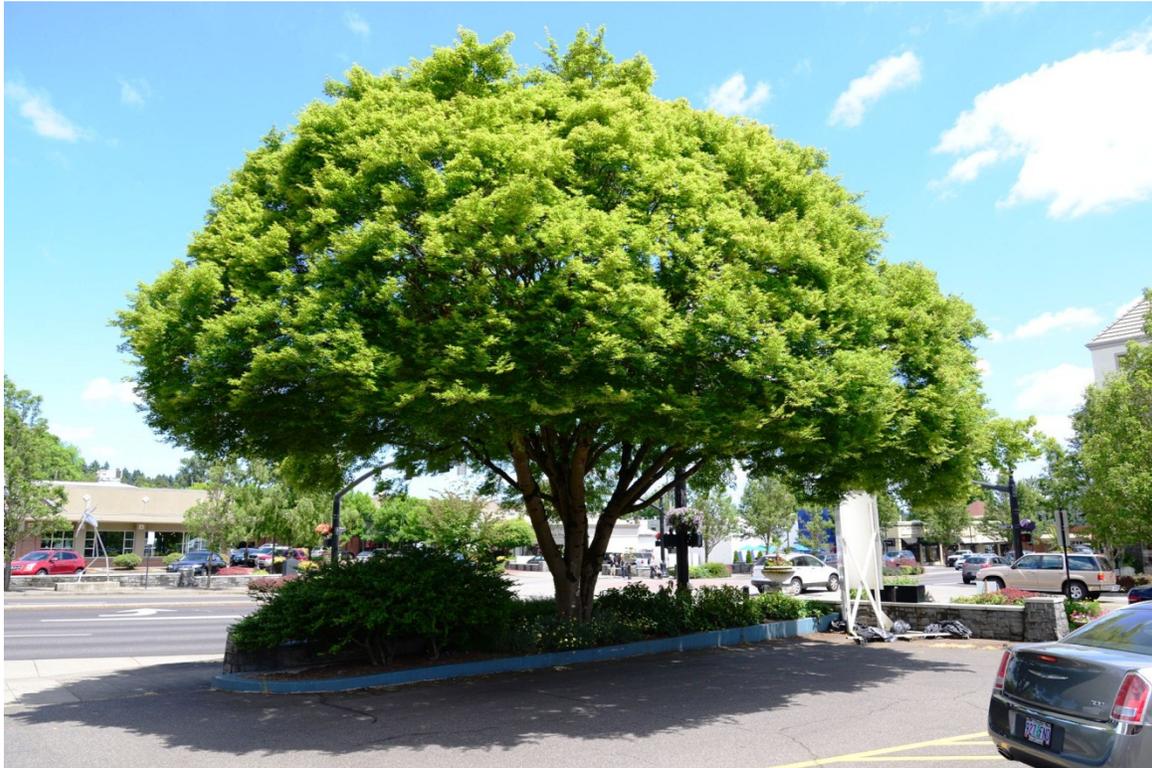
The subject Japanese maple (*Acer palmatum*) is growing in a planting area on the N.E. side of the property adjacent to a parking lot and next to the sidewalk along “A” Avenue (see Appendix #1, Photo #1). The tree is a 3 trunked specimen with the stems joined at the base of the tree. The tree is 32” in diameter as measured 18-inches above grade. The tree is approximately 30’ tall and has a spread of 50’. The tree extends over the sidewalk to the north and the parking lot to the south. The tree is growing in a long raised planter area between the sidewalk and parking lot.

The tree appears to be in good health condition. The tree has a full crown, no significant branch dieback. The tree has a strong branch structure. The incremental annual growth is normal and healthy. There is no visible sign of trunk or internal decay. I detected no sign of any significant insect or disease problems.

Photo 1 – Wizer Japanese maple located in N.E. corner of property.

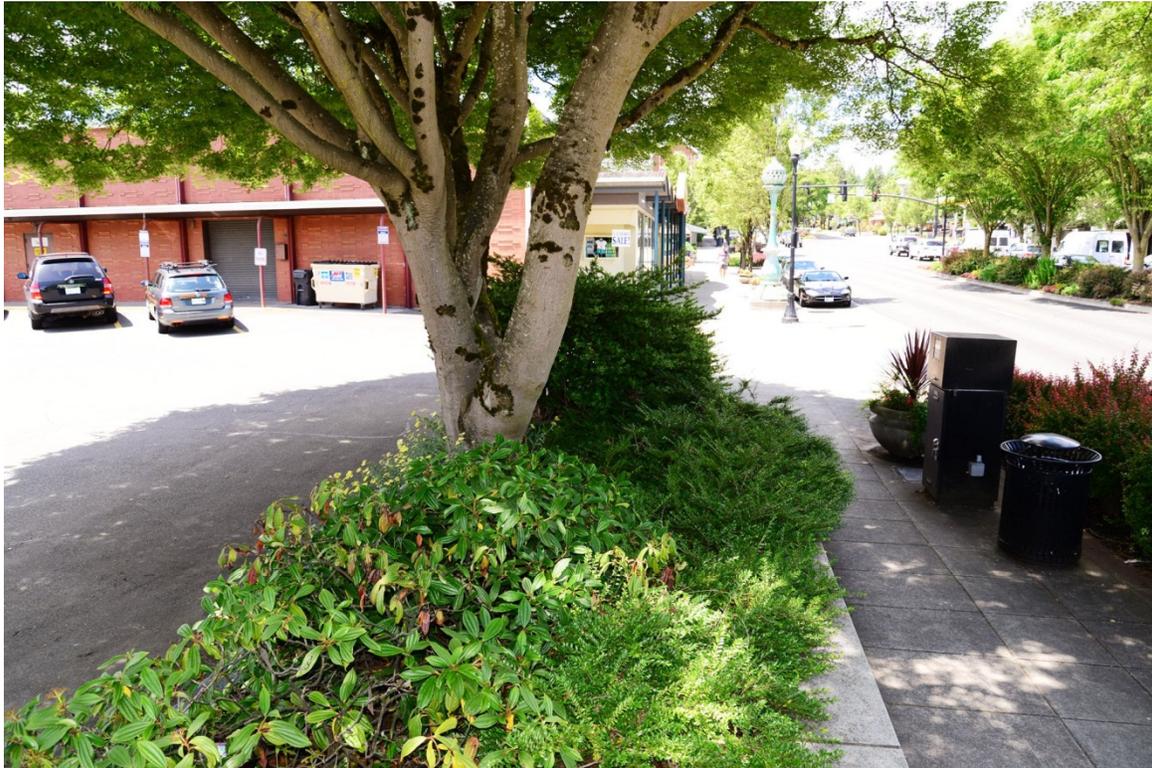
The planter is approximately 50' long by 6' wide, with the planter expanding to 10' wide in a 15' long area where the trunk is planted (see Appendix #1, Photo #2).

Photo 2 – Wizer Japanese maple in planter area.

2. Establish a TPZ by installing a chain link fence around the Japanese maple as established by the consulting arborist. This TPZ area shall consist of the current long planting bed area if the area is to remain “as is”.

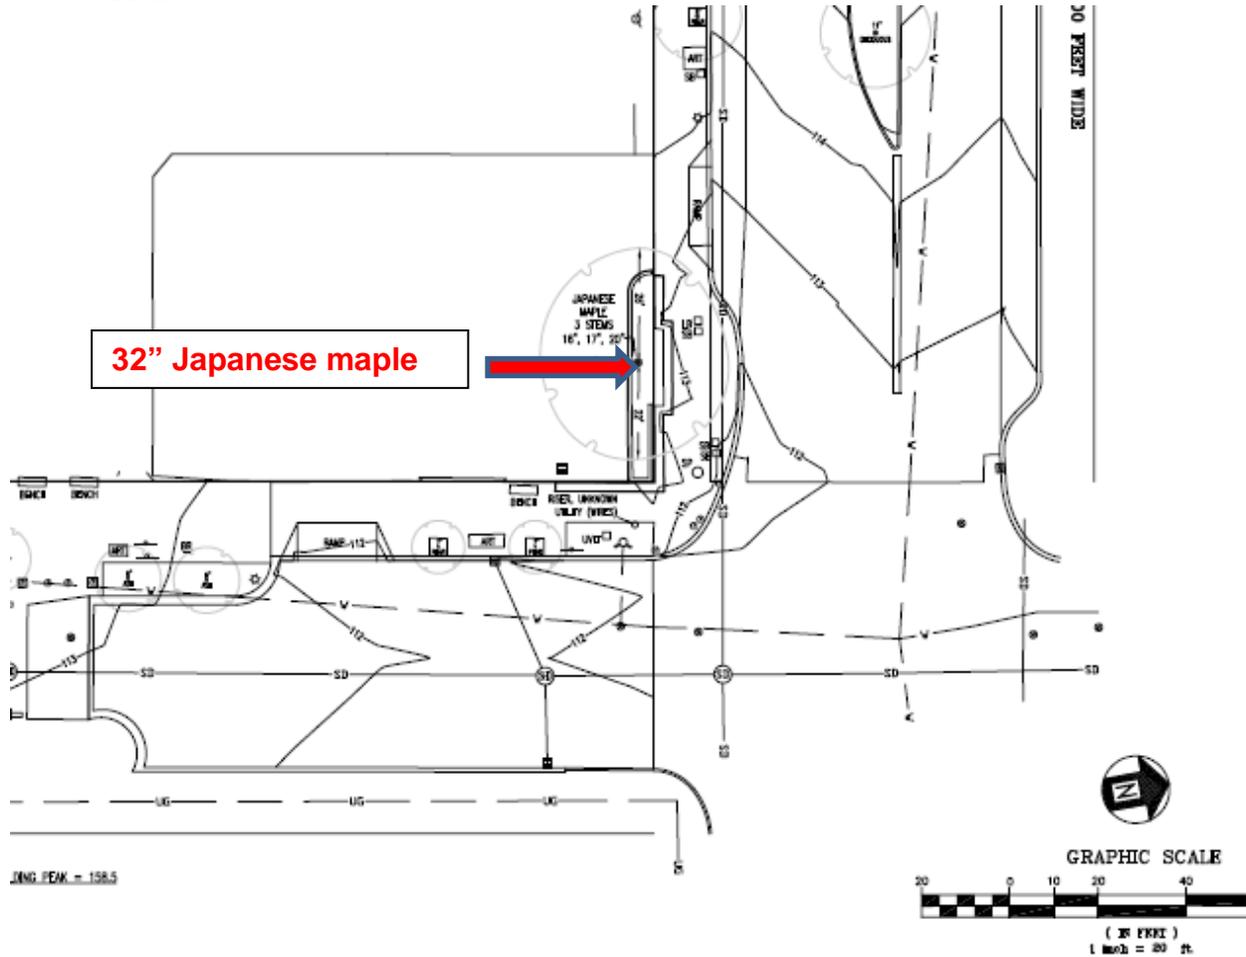
#3 Site Plan

3 Site Plan – Japanese maple in planter box adjacent to existing parking lot on the N.E. side of the property next to sidewalk along “A” street.
