SYNTHETIC SURFACE GMAX TEST REPORT

Hazelia Soccer Field

Report # 16-266 Date: August 30, 2016

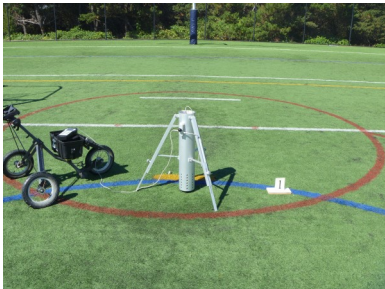
LOCATION 1

Test results herein reflect the performance of the points tested, at the time of the testing and at the temperatures reported. Under the stated test conditions listed in this report, all test points met the requirement of <200 average Gmax when tested in accordance with the ASTM F1936-10 specifications. EXCEPT DROP LOCATIONS #1, #2, #3, and #4 AS SHOWN IN RED ON PAGE 2 OF THIS REPORT.
