DATE: July 1, 2014
(revisions since the 6/27/14 version are highlighted in yellow)

PROJECT: 314126-Master Plan Review for ILU 14_0031 (The Highlands) **SUBJECT:** Summary of Storm Drainage Master Plan Peer Review and Comments

EXHIBIT A: Downstream Drainage Areas of Concern

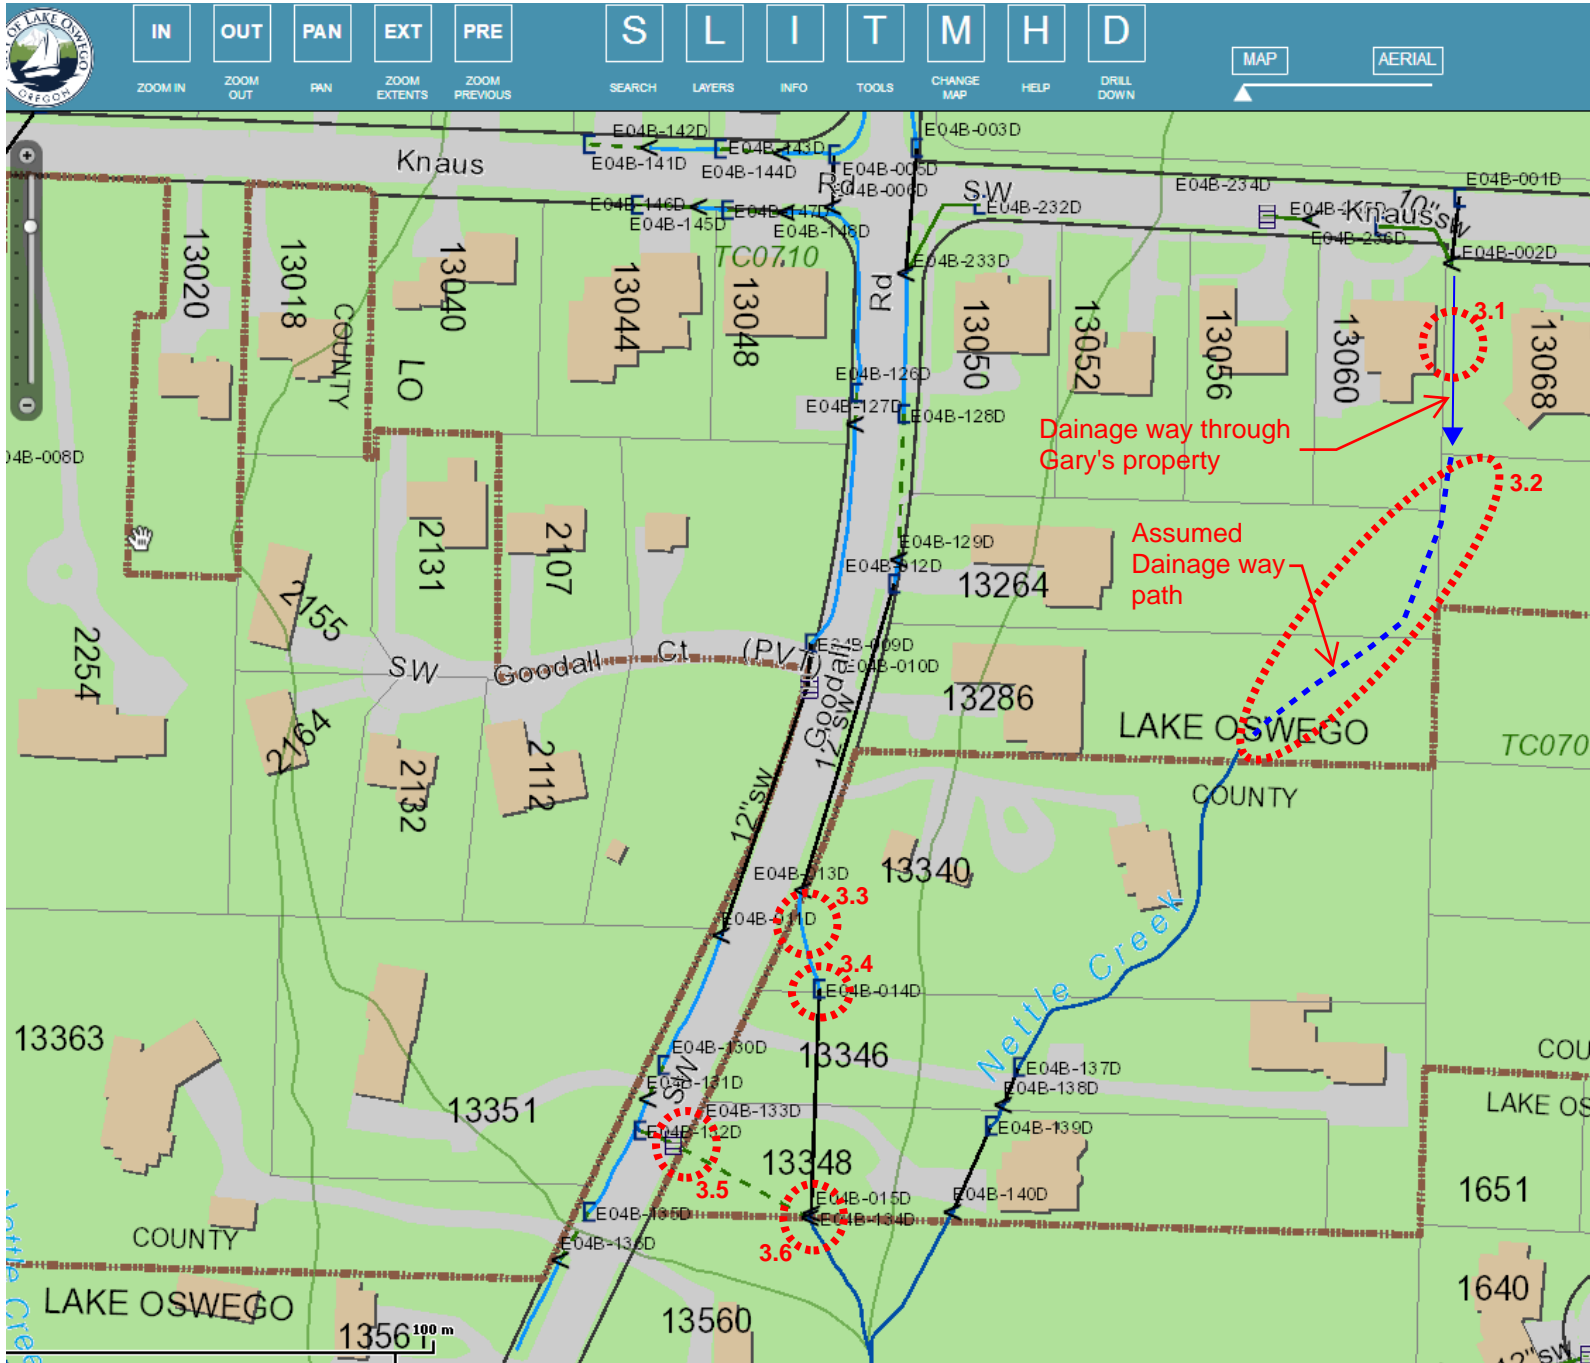
Based on a site walk through the neighborhood with Gary Willihnganz following the June 19, 2014, meeting, several areas of concern along the downstream drainage ways and ditches were noted. The following are the issues and recommendations for each of the areas of concern observed. Refer to the attached Exhibit A for their locations and Exhibit B for some photos of them.

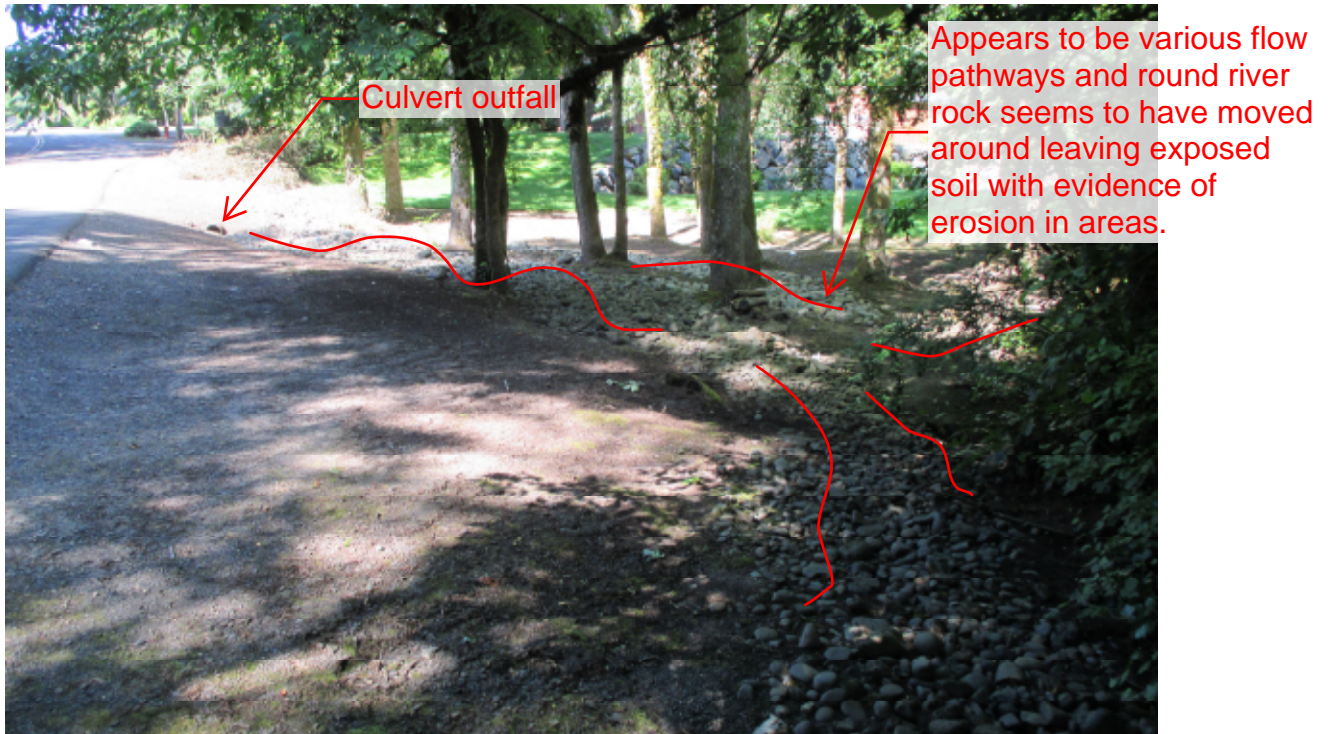
- 3.3 This is the point at which street runoff and all upstream drainage discharges out of pipe outfall and flows across bare ground and beyond the street right-of-way. Round river rock appears to have been placed to slow runoff, but has migrated and significant signs of erosion are apparent throughout area.

Area 3.3 - Culvert outfall to an undefined channel with evidence of erosion

Recommendation: Construct defined drainage channel with adequate rip-rap rock armoring and check dams if needed to prevent scouring that connects the drainage flow to the culvert opening (Area 3.4).

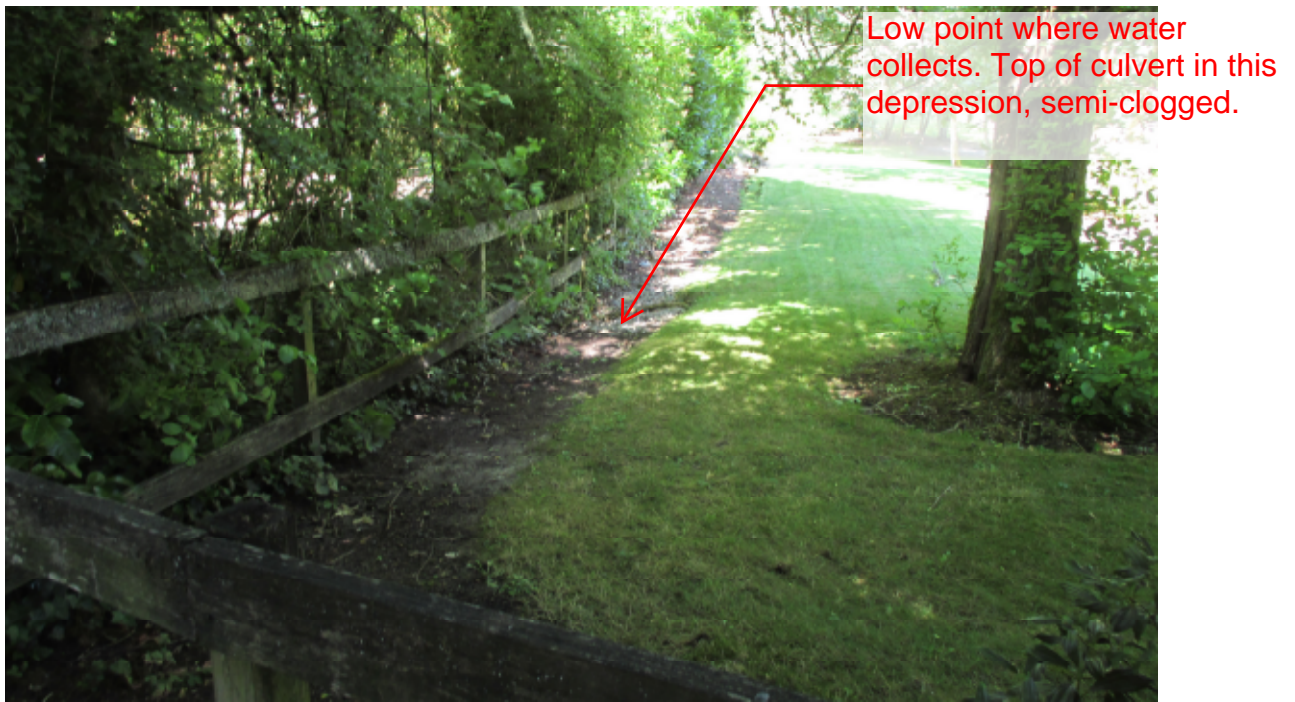
- 3.4 Surface drainage enters culvert here. Culvert appears semi-plugged.

Area 3.4 - Upstream end of culvert through private property appears semi-clogged

Recommendation: Install ditch inlet type of structure over culvert opening to limit potential clogging.

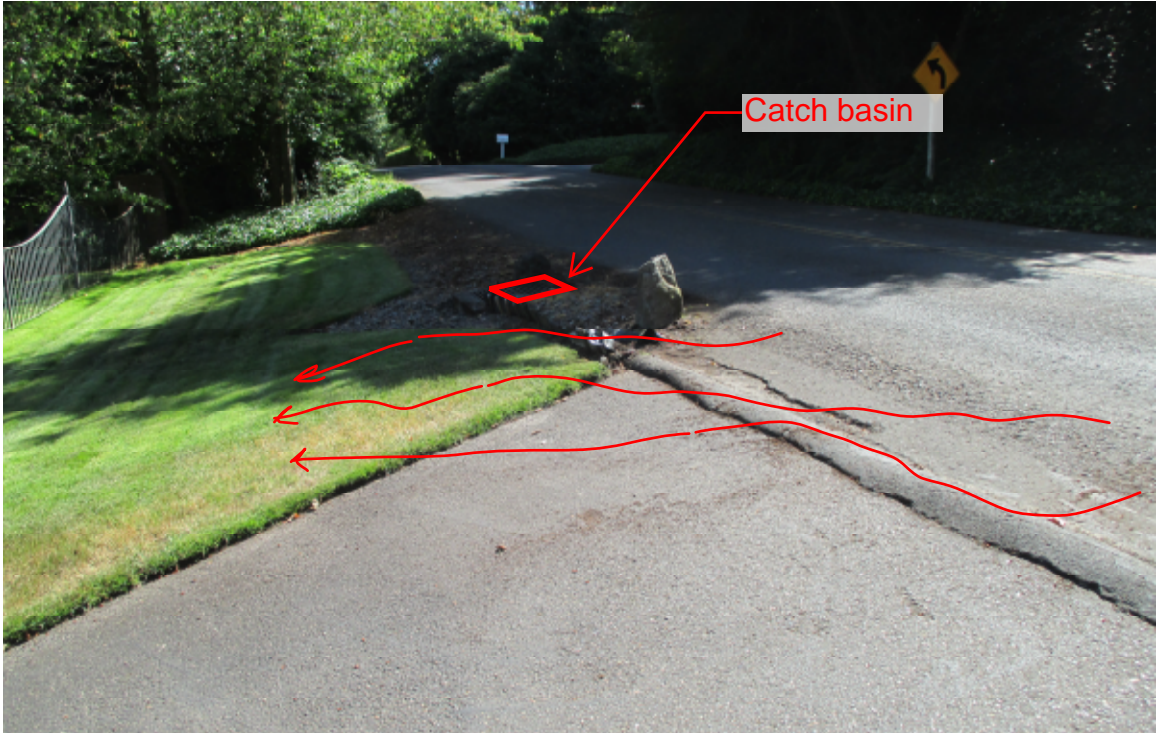
- 3.5 Drainage flows off roadway and misses street catch basin. It appears a neighbor tried to fix this by installing a short fence berm to redirect flows to catch basin.

Area 3.5 - Roadway runoff missing CB

Recommendation: Construct a more permanent and effective solution for this area to collect street runoff and convey it to the catch basin.

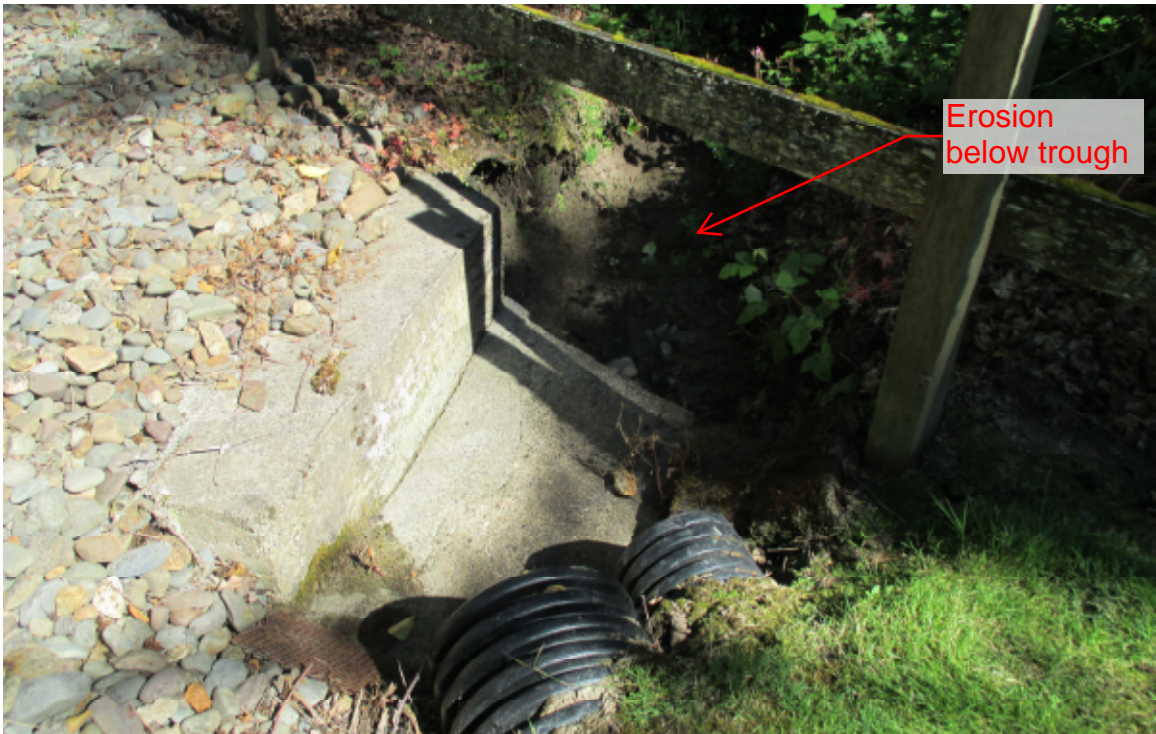
- 3.6 Multiple culverts outfall here into concrete trough. Downstream of trough, significant signs of erosion are visible.

Area 3.6 - Outfalls into concrete trough with significant erosion downstream

Recommendation: This area should be protected with appropriate amount of rip-rap to prevent further downstream erosion.
