*County: Clackamas	
*Street Address: Situs Address George Rogers Park, State Street				*City Lake Oswego	
USGS Quad Name: Lake Oswego				GPS Reading, UTM Format (Universal Transverse Mercator): Longitude: 122°39'38.54"W Latitude 45°24'39.65"N	
Township: 2S	Range: 1E	Section: IICB	Block/Lot:	Tax Lot #: 100	
Historic Name: Oswego Iron Furnace				Grouping or Cluster Name:	
*Date of Construction: 1866		Other Name: Iron Furnace Chimney (incorrect, as it was a furnace, not a chimney)			
Historic Use or Function: INDUSTRY: Blast furnace for smelting iron ore		*Current Use: Vacant		Associated Archaeological Site: Yes	
Architectural Classification(s): Industrial		Plan Type/Shape: truncated pyramid		Number of stories: N/A	
Foundation Material: Basalt Foundation laid on bedrock; 12 x 14 firebrick hearth in center		Structural Framing: N/A		Moved? No	
Roof Type/Material: N/A			Window Type/Material: N/A		
Exterior Surface Materials Primary: Local basalt/ Original stack: ashlar masonry with brick arches 10-ft. addition to top: random rubble masonry		Secondary: N/A		Decorative: Interprative Panels installed in 2012 Wrought Iron gate at each entrance installed 2010

Statement of Significance

The I

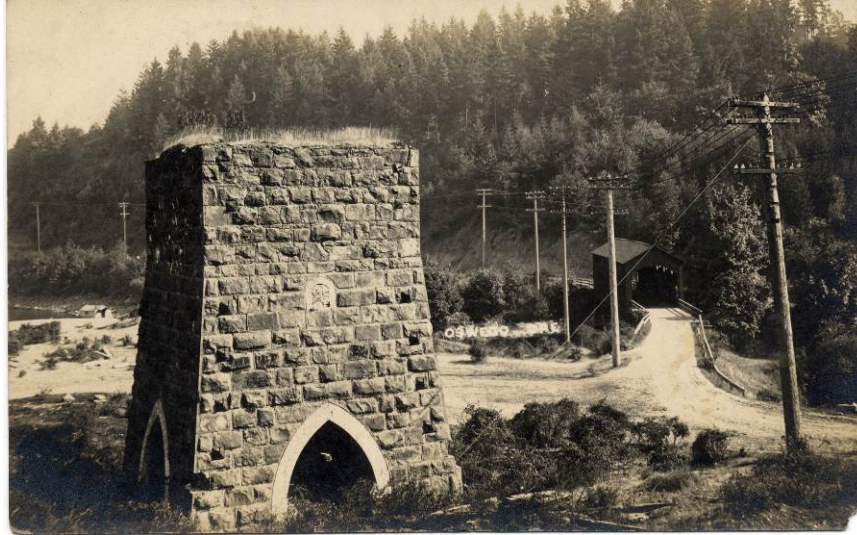
Figure 3. Blast furnace and Old River Road bridge. 1911.
Photo courtesy of the Lake Oswego Public Library. Photo ID. 131d

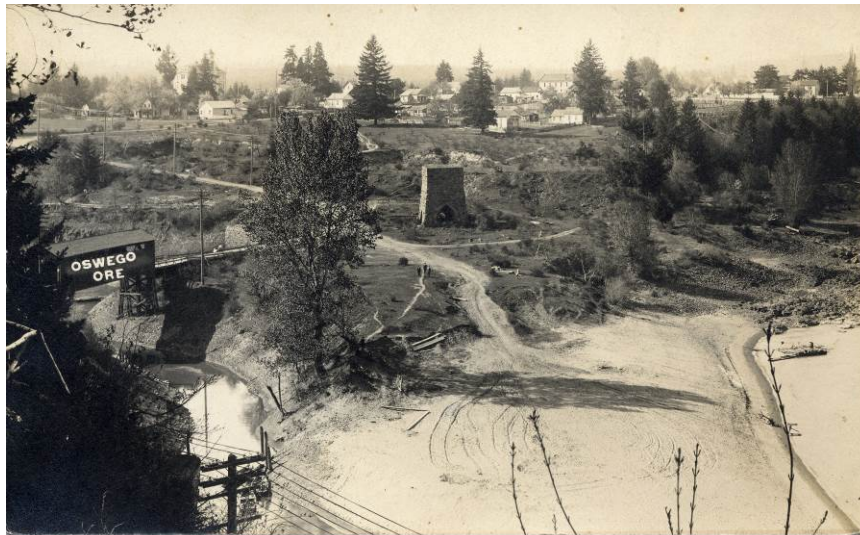
Figure 4. Postcard, furnace, center. Date unknown.
Photo courtesy of the Lake Oswego Public Library. Photo ID. 2289

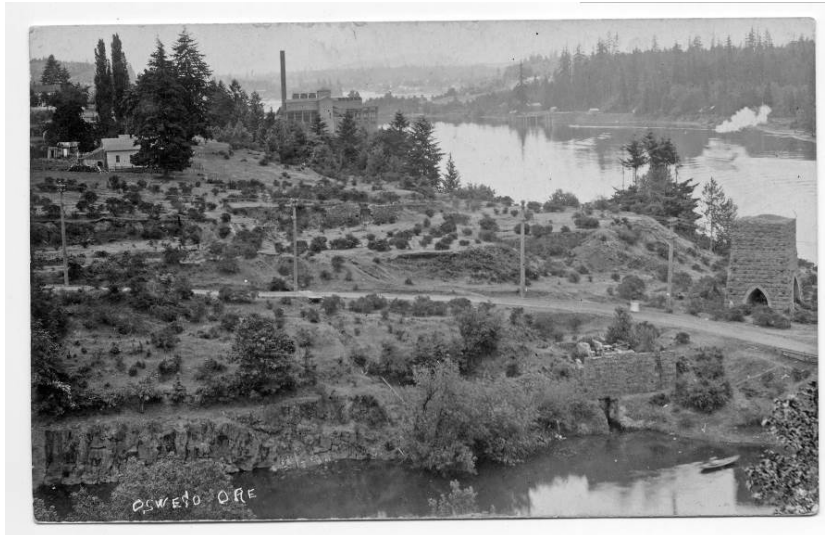
**Figure 5. Imprinted Oswego Ore, . unknown.
Photo courtesy of the Lake Oswego Public Library. Photo ID:133B**

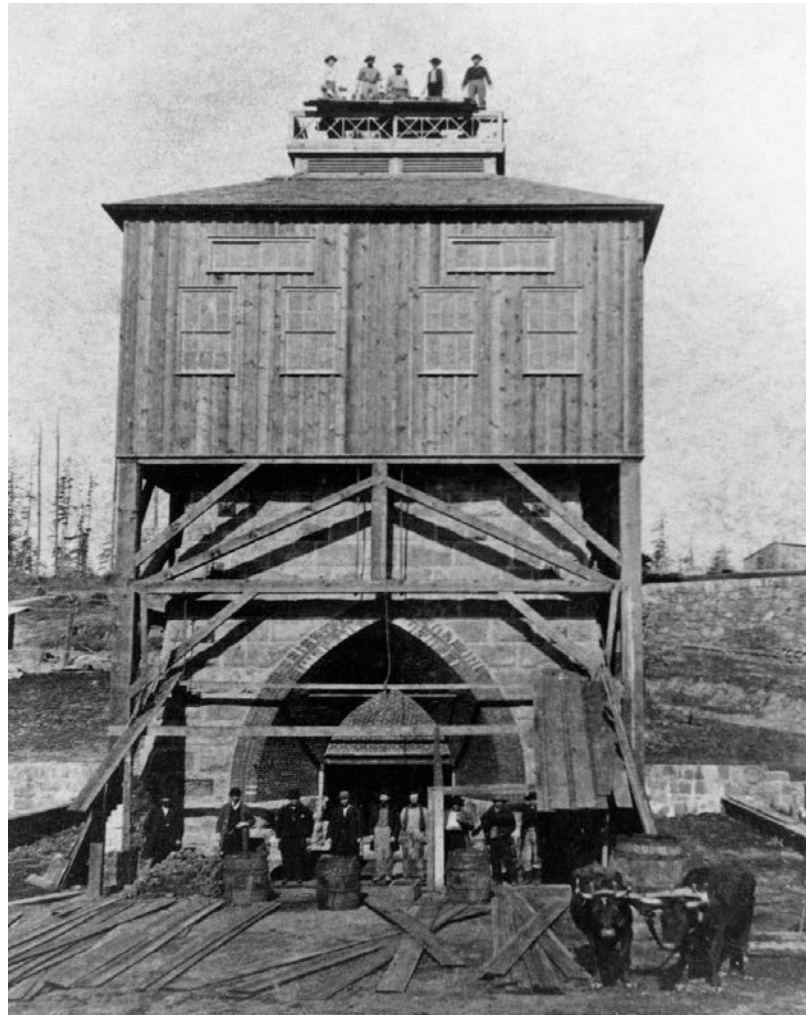
**Figure 7. Likely the oldest picture of the furnace. 1867.
Photo courtesy of the Lake Oswego Public Library. Photo ID:770b**

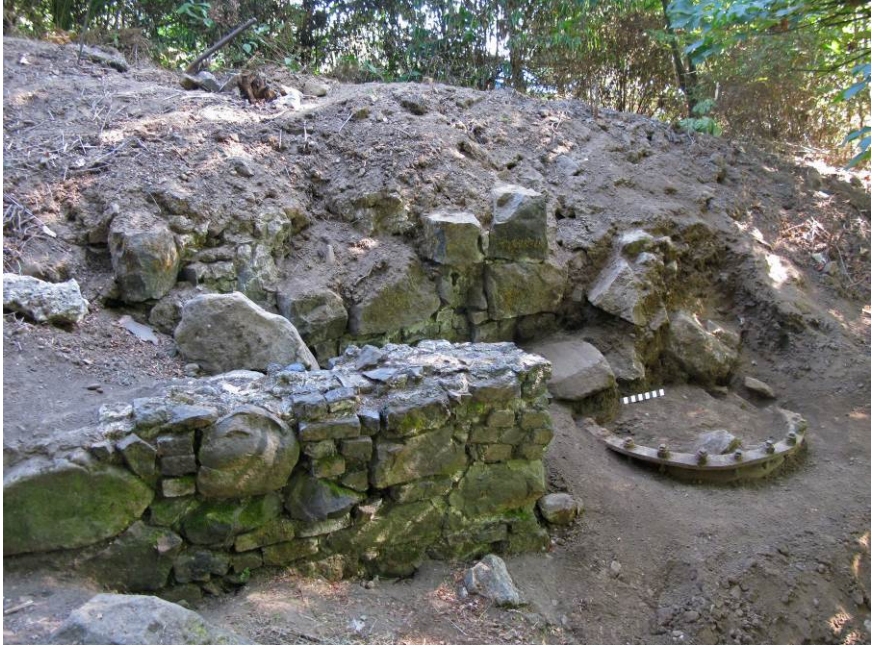
Figure 8. Blast House ruins. 2012.
Photo by Susanna Kuo

The blast house foundation is the most significant surviving remnant of the iron works after the furnace. It was built above the creek just west of the furnace.⁵ A flume running down the north side of the creek carried water to the turbine inside the blast house. According to an August 27, 1867, article in *The Oregonian*, the building was 38 square feet. A Leffel double turbine water wheel drove the blowing engine, which consisted of a pair of wooden tubs fitted with pistons driven by a walking beam (*The Oregonian* 1867). Pressurized air from this machine was sent through a long pipe to the heat exchanger on top of the furnace. Portions of the blast house foundation survive, but outflow from a culvert under Green Street has eroded much of it. In the summer of 2012 the city installed a large drainage pipe to channel water away from the foundation. While this work was being done, the site was photographed and surveyed by senior archaeologist Rick Minor of Heritage Research Associates and Lake Oswego researcher Susanna Kuo. Portions of three parallel walls can be seen above the ground. They appear to be interior walls rather than perimeter walls of the building. The top of a large iron cylinder 45 inches in diameter is exposed near the lowest wall. A flange around the rim is studded with heavy iron bolts. This may have been the discharge cylinder for the water turbine (Leffel News Print 1885). Three large anchor bolts protrude from the tallest wall, which is completely buried except for its top.

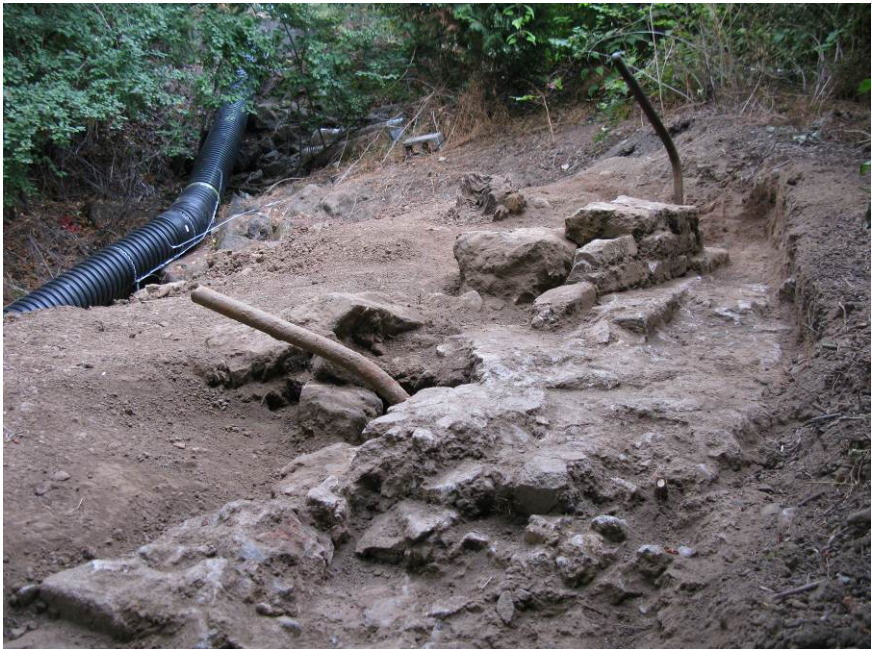
Figure 9. Blast House ruins. 2012.
Photo by Susanna Kuo

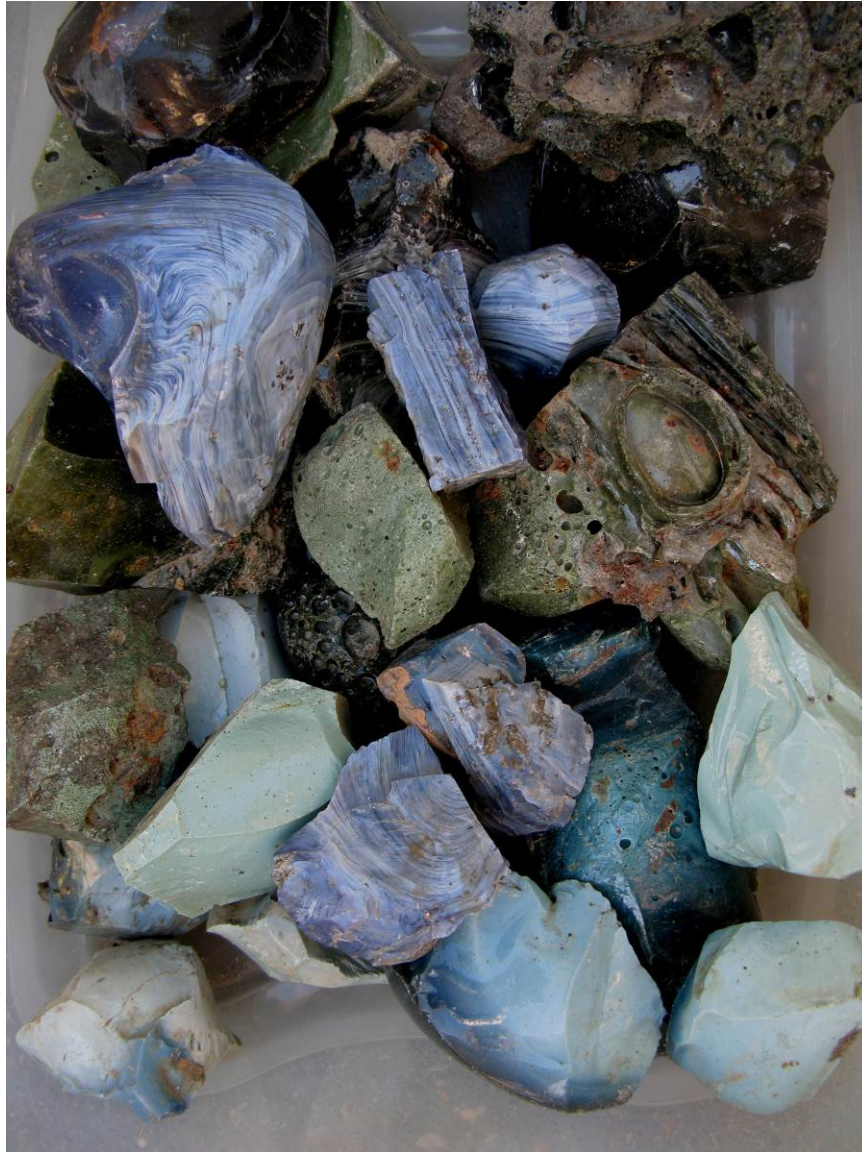
**Figure 10. Slag from George Rogers Park. 2009.
Photo by Susanna Kuo**

Although slag heaps might seem to be of little consequence, they are the most enduring feature at furnace sites and can reveal much about the type and quality of iron produced there. Other artifacts are often found in slag deposits so they are a valuable archaeological resource (Weitzman 1980:142–143). In George Rogers Park, slag deposits cover much of the riverbank as well as the creek bank near the north end of the footbridge. During the park renovations of 2005, several of these deposits were exposed while a path and the stairway to the beach were being constructed. The slag in George Rogers Park is predominantly black, but there is a wide range of colors from sapphire blue to turquoise and green. The texture also varies enormously from solid, glassy chunks to frothy pieces that will float. Materials found in the slag deposits during archaeological monitoring included nails and spikes, firebricks, ceramic fragments, and a bar of pig iron (Minor 2006:11–14, 30–33). The two “salamanders” were also discovered on top of the slag deposits. A giant mass of slag and firebrick (probably the product of a furnace accident) rests on top of a slag deposit near the north end of the footbridge over the creek.

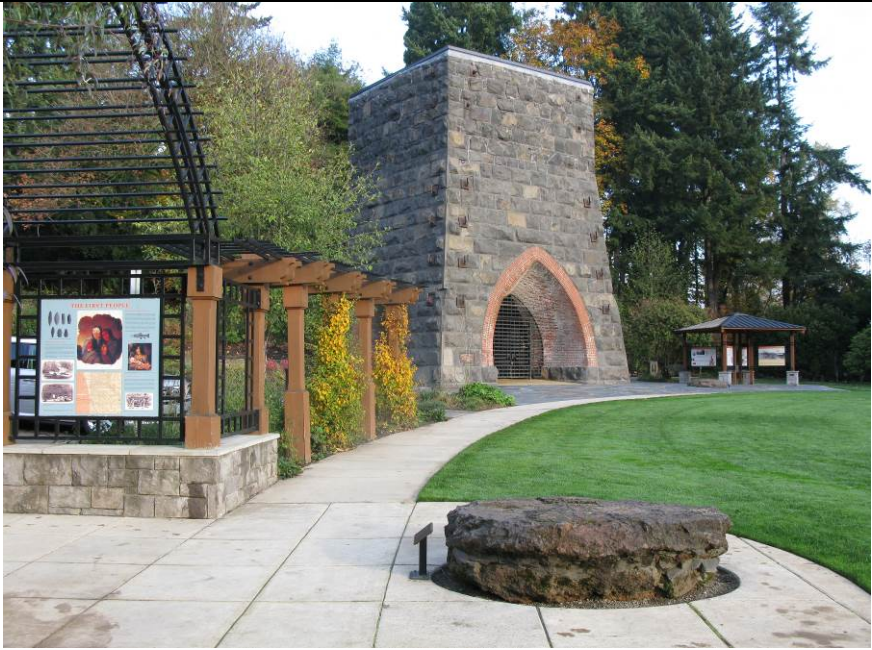
**Figure 11. Salamander, with furnace in back, George Rodgers Park. 2010
Photo by Susanna Kuo**

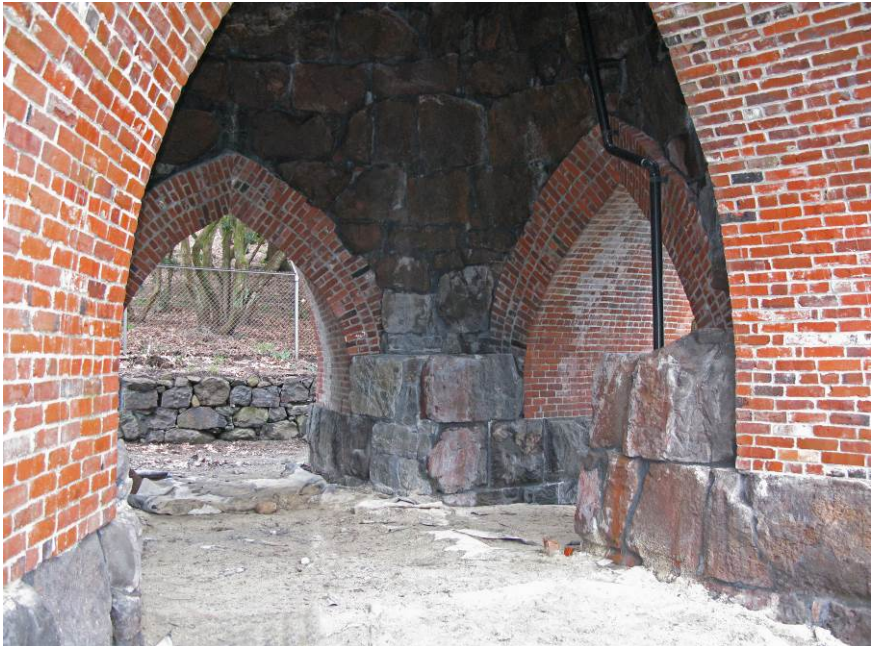
**Figure 12. Blast House. 2010.
Photo by Susanna Kuo**

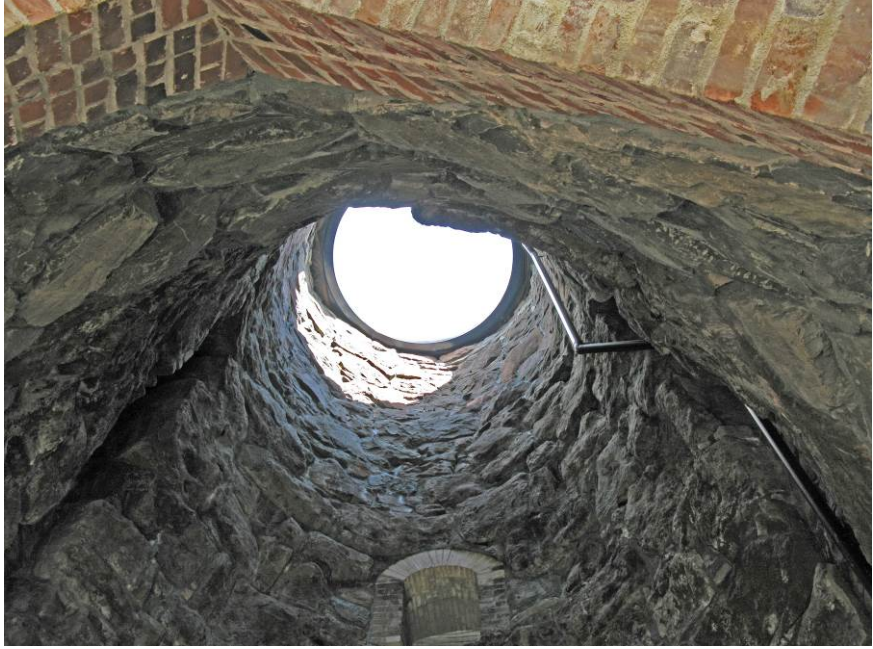
Figure 13. Furnace, interior, looking up, George Rodgers Park. 2010
Photo by Susanna Kuo

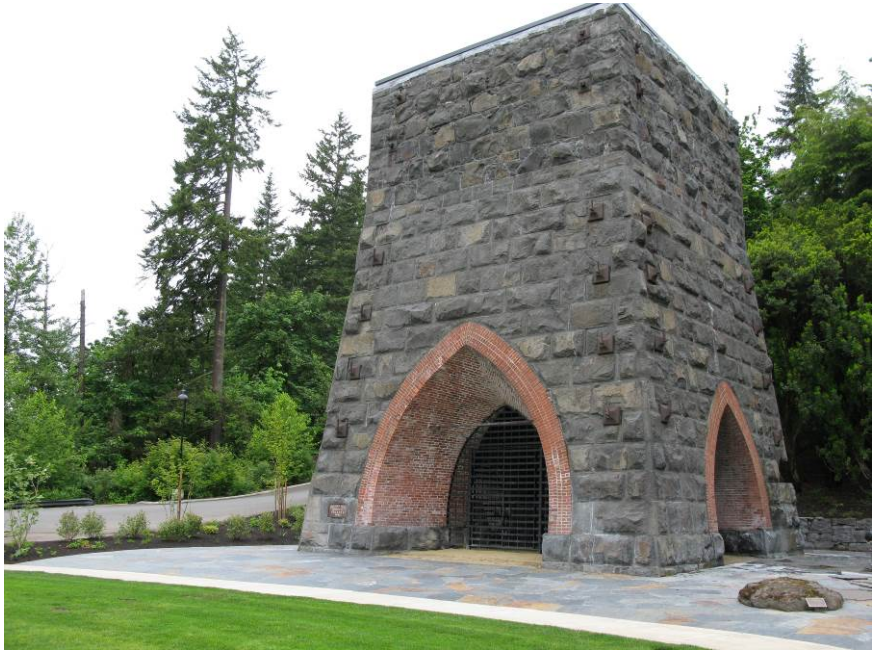
Figure 14. Furnace 2010.
Photo by Susanna Kuo

Exterior Alterations or Additions, Approximate Date: 10 feet added to the furnace height in 1868. Furnace rehabilitated in 2010, includes wrought iron gates at each entrance and a led cap to preserve the stonework					
Number and Type of Associated Resources: Three stone retaining walls: 1) directly behind furnace; 2) on road behind furnace (deteriorated); 3) on property line between #525 and #475 Furnace Street. The adjacent lake and creek supplied water power, The river landing provided transportation. The blast house was located adjacent to the creek and supplied forced air to the furnace. Other associated resources include; the Prosser Mine site, the Charcoal Pit sites, the Pipe Foundary site, and the worker's cottage.					
Integrity: Good	Condition: Excellent	Local Eligibility: On National Register and City LDL		National Register Listed? <input checked="" type="checkbox"/> Yes <input type="checkbox"/> No <input type="checkbox"/> Unknown
