HISTORIC IRON COMPANY WORKERS COTTAGE
PRESERVATION PLAN

CITY OF LAKE OSWEGO

THE OFFICE OF ROBERT DORTIGNACQ ARCHITECT
MARCH 31, 2008

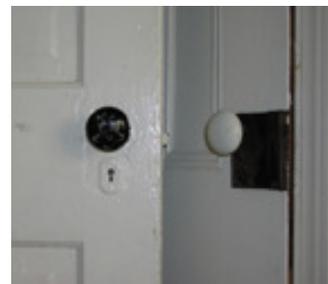
The front door, and possibly the rear door are in their original locations with frames intact. The doors have been replaced with newer ones of a six panel configuration with cylindrical locks and deadbolts. The front door measures 2'-8"

x 6'-8" and has a wood screen door. The rear door is 2'-6" x 6'-4" (cut down) with a metal storm door.

The wood windows are in good condition, but need some repairs and care. There is no way to hold the window open at a particular position, only at the point that the friction of the sash stops support the sash. This means that in the lowered position the sash is loose, allowing substantial air infiltration. It also means that there is a danger that the sash can come crashing shut at any moment. The vinyl windows detract from the historic quality of the cottage in design, material, size and configuration.

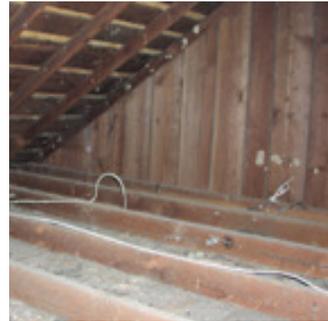
The primary roof structure is front gabled with a pitch of 8:12 and has a one foot overhang on all sides. The overhangs square cut and are enclosed with soffit boards. Roof joists are 2"x6" spaced at 24" o.c. and rafters are 2"x 3½" also spaced at 24" o.c. The joists are slightly notched over the wall plate (wall plate not visible from the interior). The rafters lap the joists, have a slight notch allowing an extension for the overhang, butt against each other directly at the ridge line without a ridgeboard. The rafters support spaced 1x sheathing of varying widths. Remains of the wood shingles can be seen in the attic. The current roofing is 3 tab plain composition shingles installed over plywood. There are painted metal eave and rake flashings. There is no rain drainage on the main roof. The attic can be accessed only by removing a small vent in the rear gable wall.

The shed roof meets the rear gable wall just below the eave and pitches south at 5:12 to a low, 6'-5" height at the rear wall. There is no access to this attic space, but it appears from the exterior that the framing is of 2x4 members. The ceiling line is level for 44" before assuming the slope of the roof. It could not be verified if the ceiling is original, it may all have been sloped originally. A white vinyl gutter collects rain from the shed roof where it is directed to a downspout at the southwest corner and from there to grade. A relatively recent photograph shows the east portion of the roof with a short overhang and no gutter.

Generally, the roof lines appear straight without significant sagging despite the small sized members. It covers, after all, a small area with short spans with an adequate pitch. The original wood shingles were a lighter covering than the current composition roofing installed on plywood. The framing is sound and dry. Signs of moisture were found around the chimney, but they appear to be from previous leaks. The chimney masonry and joints are in good condition as are the shingles. There is some debris, prior wood shingles, wasp nests, and no ceiling insulation in the attic space.

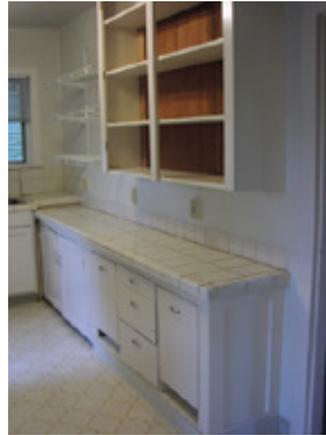
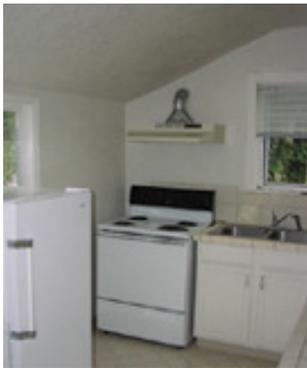
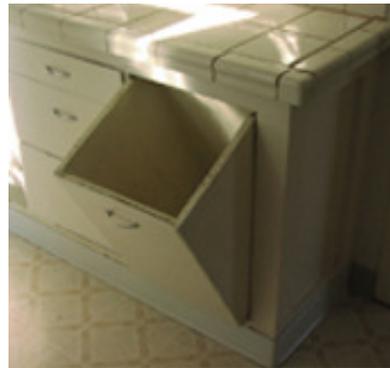
Cabinetry is limited to the kitchen and a small surface mount medicine cabinet in the bathroom all of which is painted wood. The cabinets in the kitchen consist of a face framed wall unit on the north wall, and a continuous base cabinet below. An 'L' is formed at the west wall with a newer (since 2000) sink cabinet. The base cabinet has a tiled (non historic) top that steps up at the west end. It also has a drawer stack and two large bins for storing staples, an historic feature not used in current times. The wall cabinet doors are missing. There are additional coated wire wall shelves in both the kitchen and bathroom.

The appliances include a free standing electric range with hood (vents through west wall), an apartment sized single door refrigerator, a stacked electric washer-dryer (vents through south wall). The appliances all appear to operate satisfactorily, and would be easily replaced if worn out. The layout and circulation of the kitchen is awkward and it could be improved.
