SYNTHETIC SURFACE GMAX TEST REPORT

Hazelia Soccer Field

Report # 16-266 Date: August 30, 2016

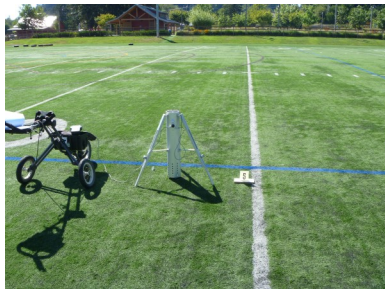
LOCATION 4

Test results herein reflect the performance of the points tested, at the time of the testing and at the temperatures reported. Under the stated test conditions listed in this report, all test points met the requirement of <200 average Gmax when tested in accordance with the ASTM F1936-10 specifications. EXCEPT DROP LOCATIONS #1, #2, #3, and #4 AS SHOWN IN RED ON PAGE 2 OF THIS REPORT.

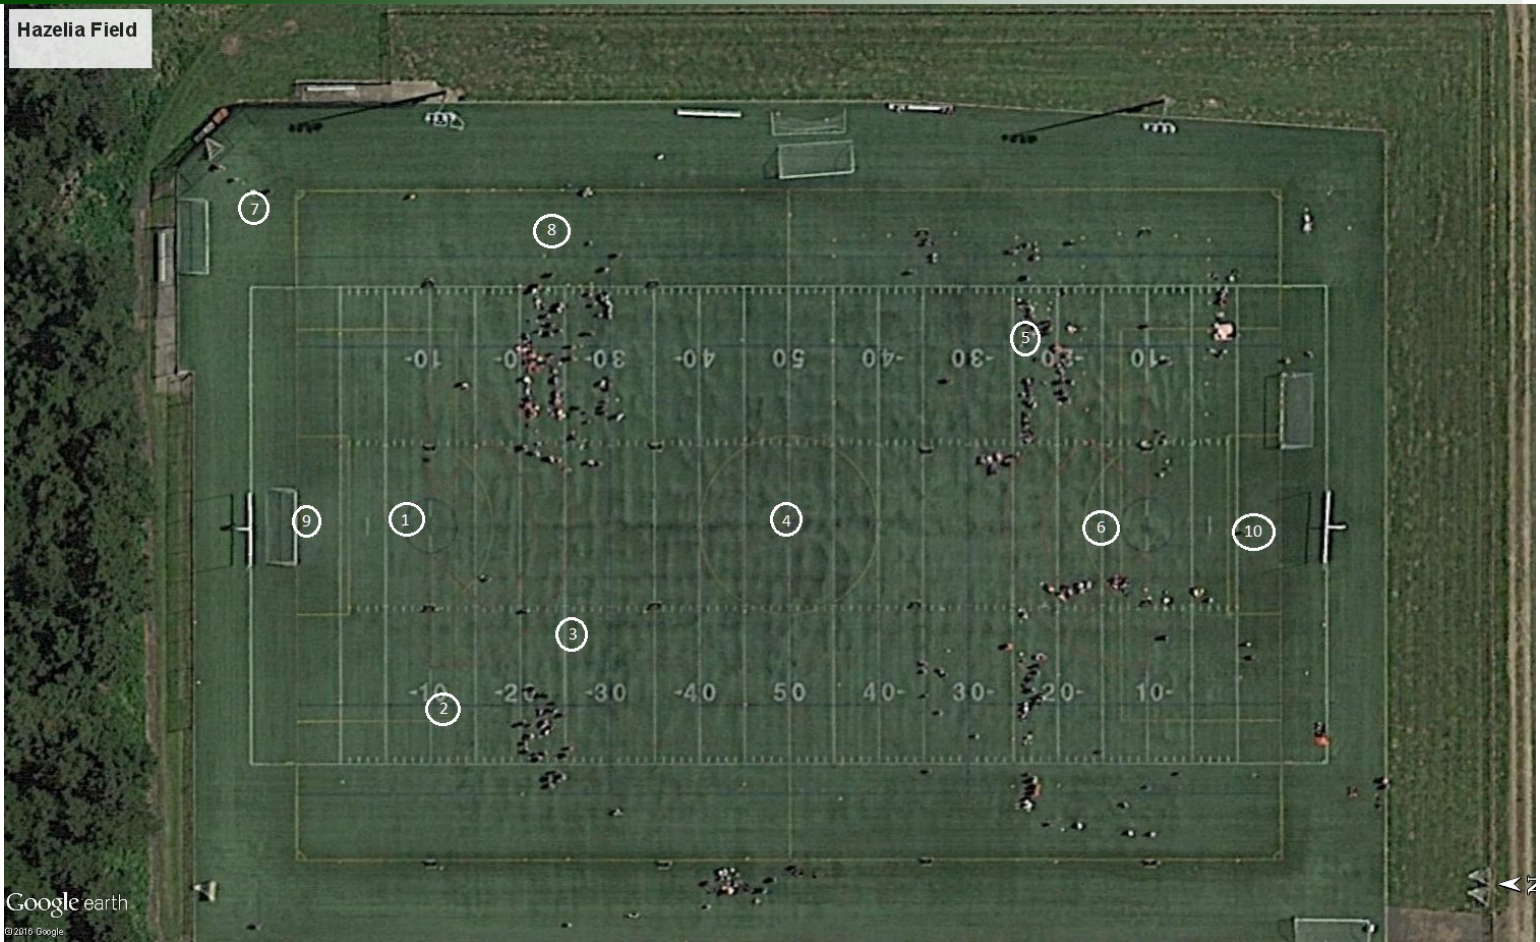
GMAX TESTING MAP

<u>VALUE</u>	<u>LOCATION (See map page 3)</u>
Maximum Gmax (G's)	<u>221</u>	<u>1</u>
Minimum Gmax (G's)	<u>160</u>	<u>7</u>
Average Gmax (G's)	<u>190</u>	<u>N/A</u>
Maximum Infill Depth (mm)	<u>34</u>	<u>5,7</u>
Minimum Infill Depth (mm)	<u>17</u>	<u>1</u>
Average Infill Depth (mm)	<u>27</u>	<u>N/A</u>
