Lake Oswego  
Public Golf  
Course

Stafford Rd

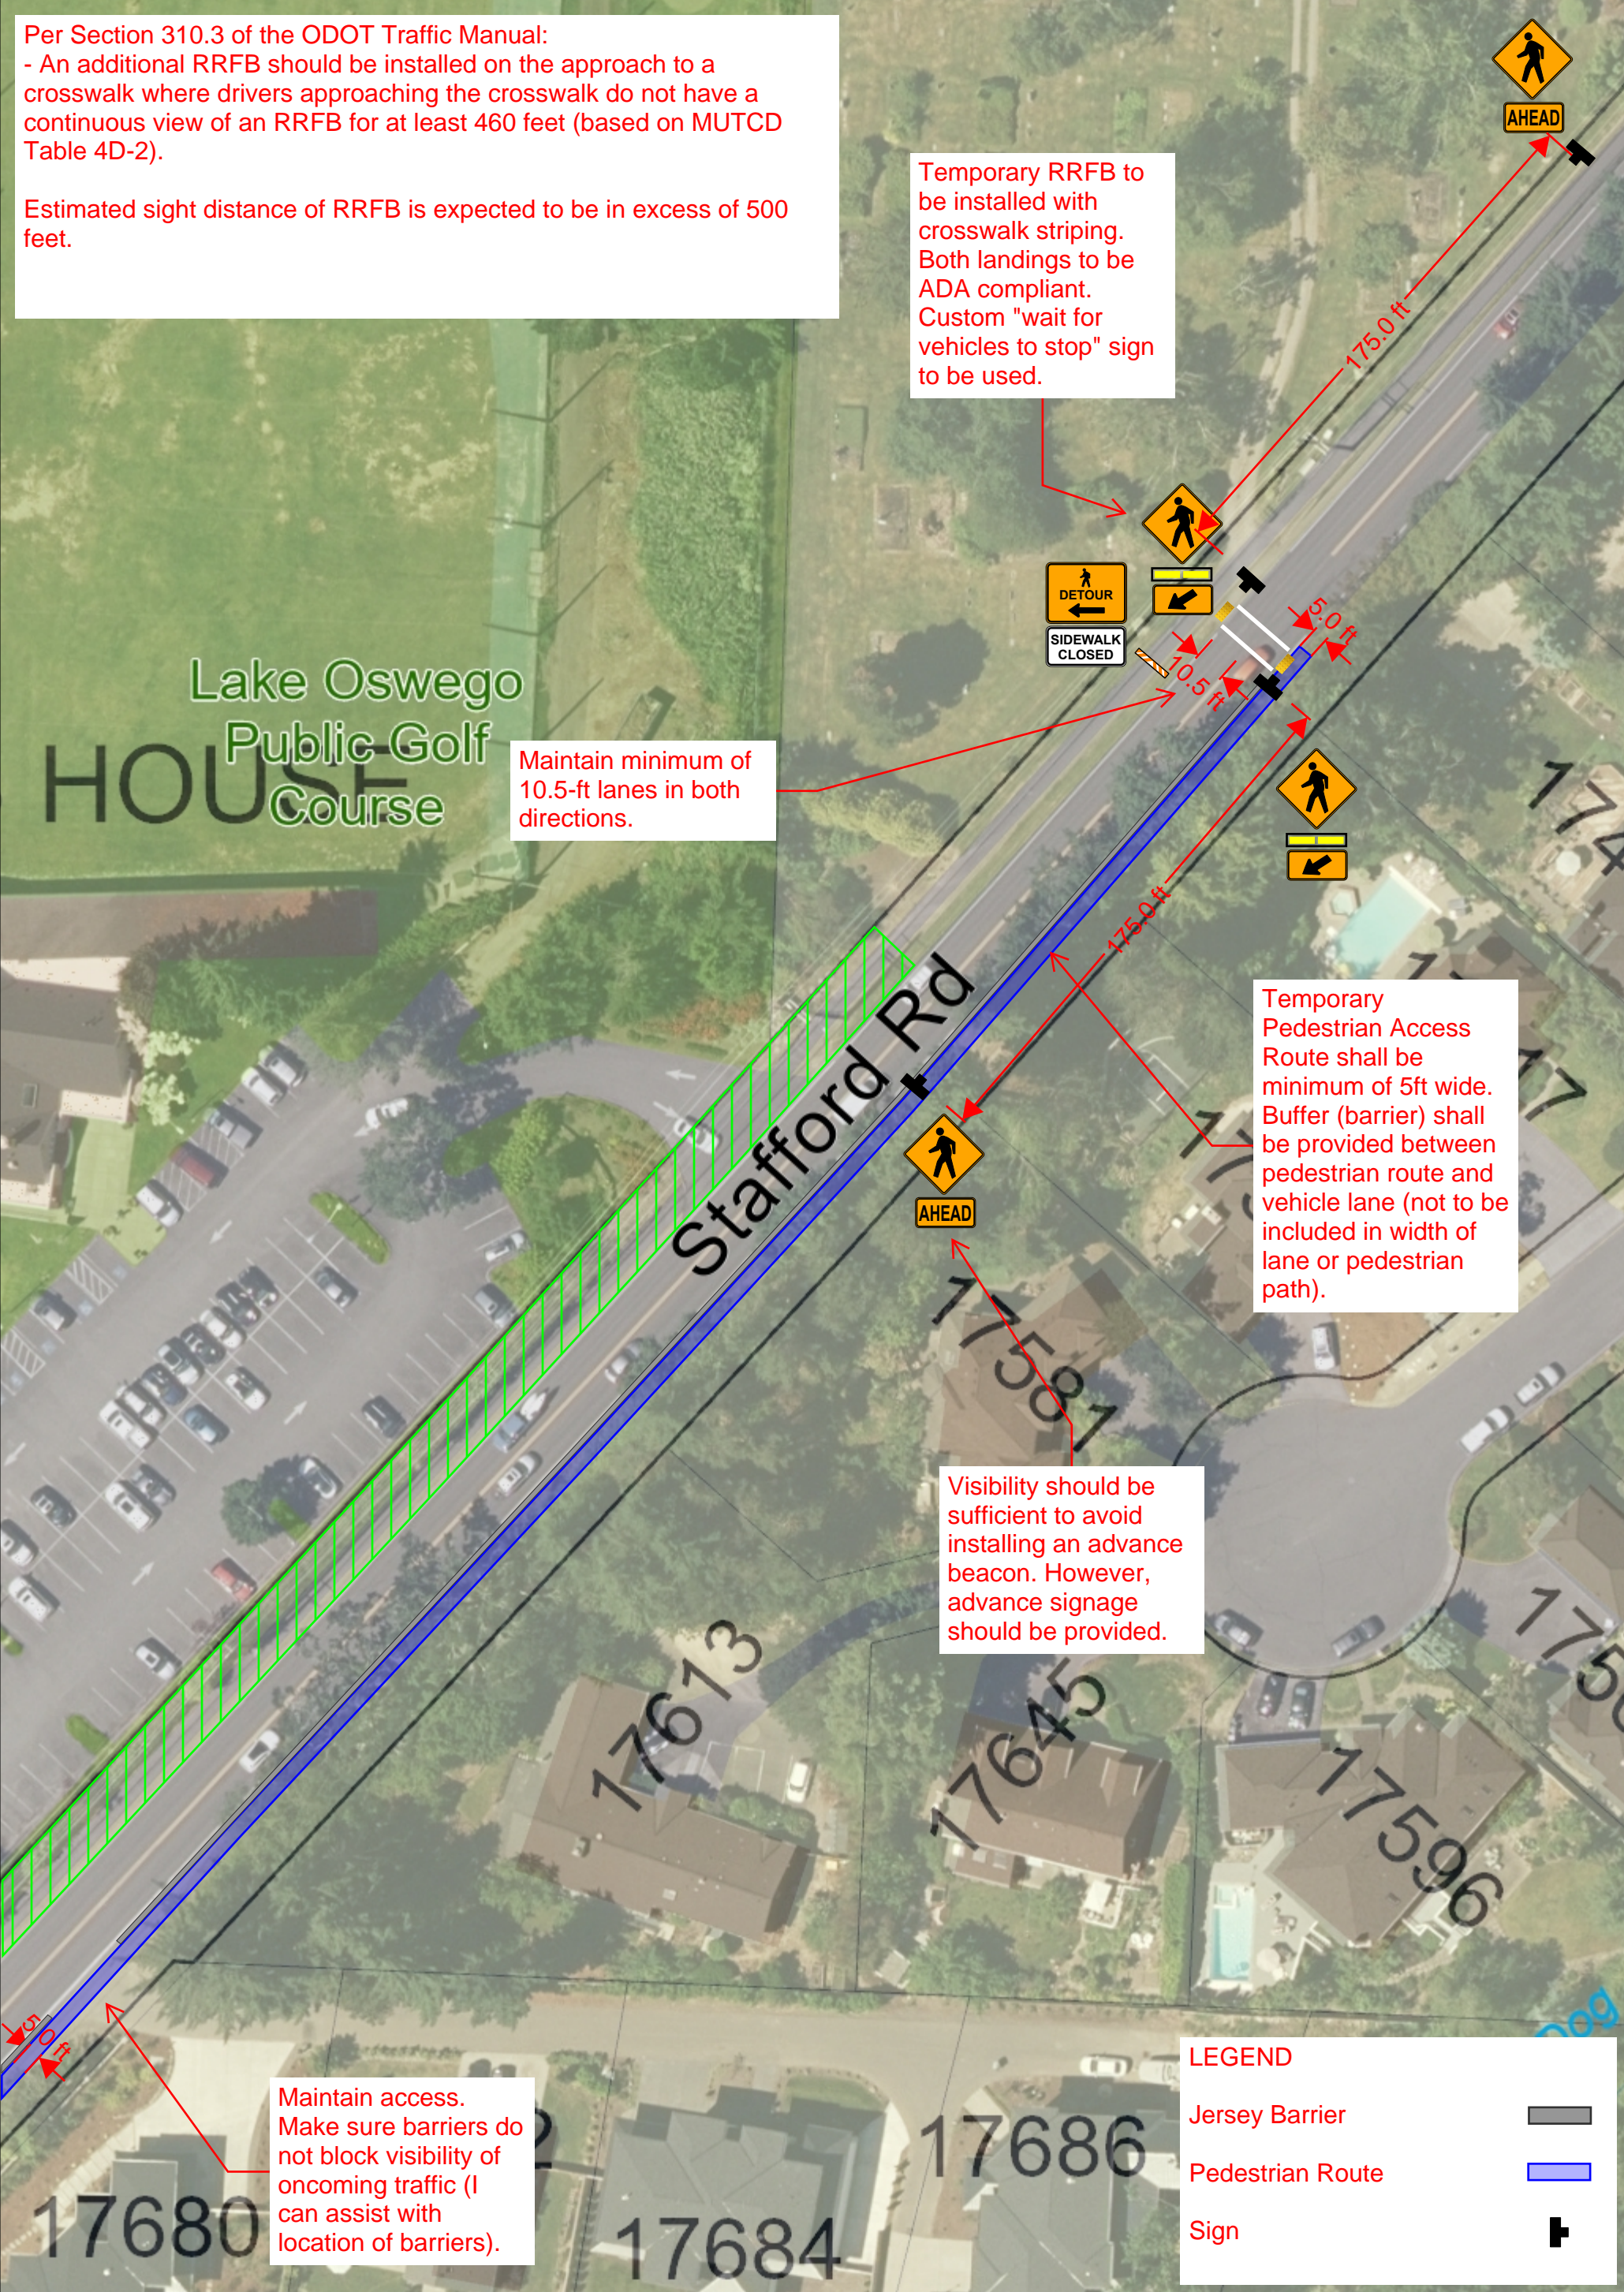
Per Section 310.3 of the ODOT Traffic Manual:  
 - An additional RRFB should be installed on the approach to a crosswalk where drivers approaching the crosswalk do not have a continuous view of an RRFB for at least 460 feet (based on MUTCD Table 4D-2).

Estimated sight distance of RRFB is expected to be in excess of 500 feet.

Temporary RRFB to be installed with crosswalk striping. Both landings to be ADA compliant. Custom "wait for vehicles to stop" sign to be used.

Maintain minimum of 10.5-ft lanes in both directions.

Temporary Pedestrian Access Route shall be minimum of 5ft wide. Buffer (barrier) shall be provided between pedestrian route and vehicle lane (not to be included in width of lane or pedestrian path).

Visibility should be sufficient to avoid installing an advance beacon. However, advance signage should be provided.

Maintain access. Make sure barriers do not block visibility of oncoming traffic (I can assist with location of barriers).
